RHBL 7325 ENVIRONMENTAL ANALYSIS

By: Whitney Musick

UALR's Ottenheimer Library

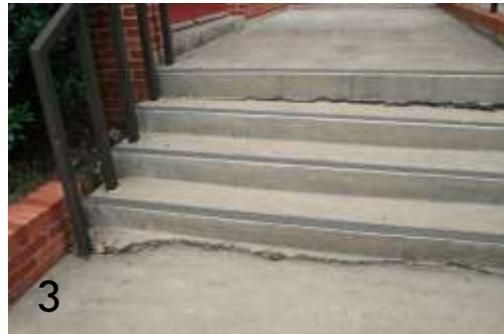
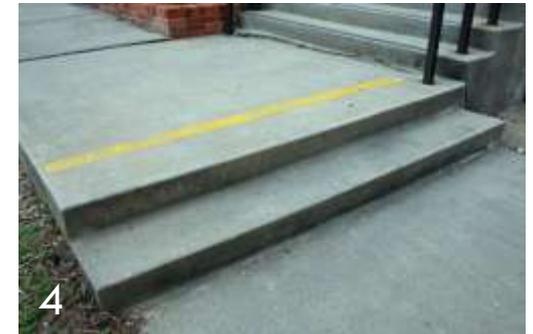
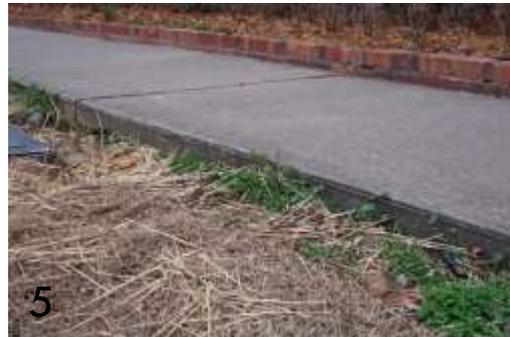
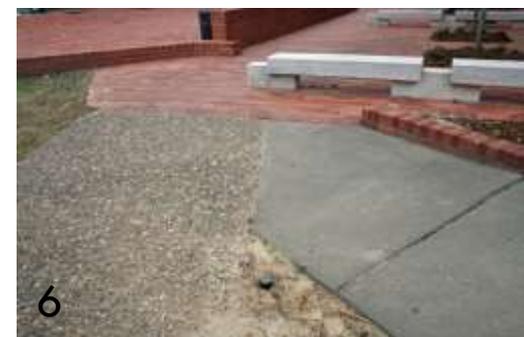
East Side Obstacles

1. Uneven pavement leading to stairs without handrails

2. Close-up of uneven pavement located in front of stairs

3. Concrete cracking at stairs

4. Fading safety stripe

5. Sidewalk with no side barrier

6. Uneven convergence of different textured sidewalks at the southeast corner of the library

- Repair and smooth out imperfections in walkway.
- Add high-contrast non-skid tape to the edge of all steps.
- Repaint and add yellow striping at the beginning and end of stairways.
- Place handrails at each set of exterior stairs that do not have them in place in order to prevent individuals from falling off the side of the steps.
- Build up elevation of ground beside sidewalk with dirt to eliminate drop-off.

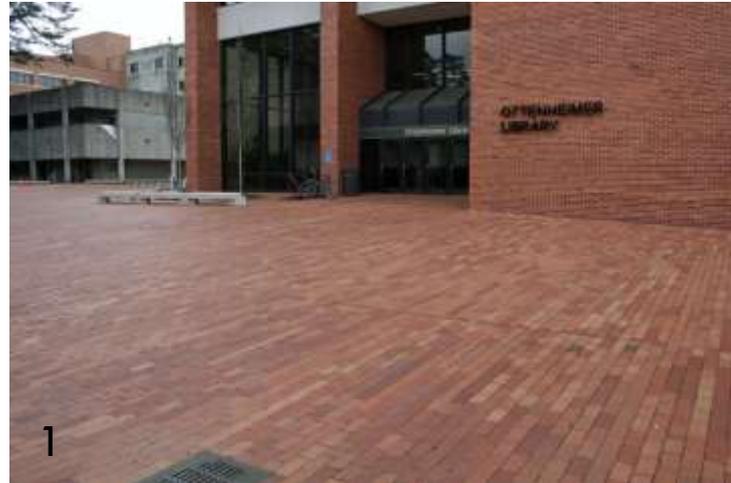
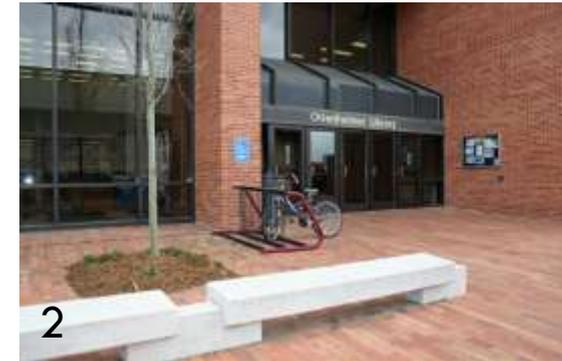
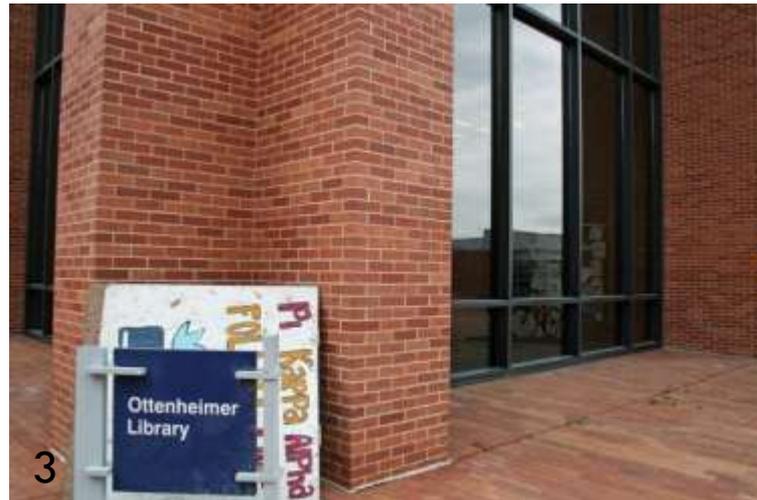
South Side Obstacles

1. Brick pavement leading up to brick building
2. Bench, tree, and bike rack near front entry
3. Alcove at southwest edge of building

- Create striping at the bottom of the building so that the paving and building can be easily differentiated. This would also help identify bends in the structure that create alcoves.
- Add high-contrast markings around trees to denote their location.
- Paint bike rack a contrasting color from the red brickwork.

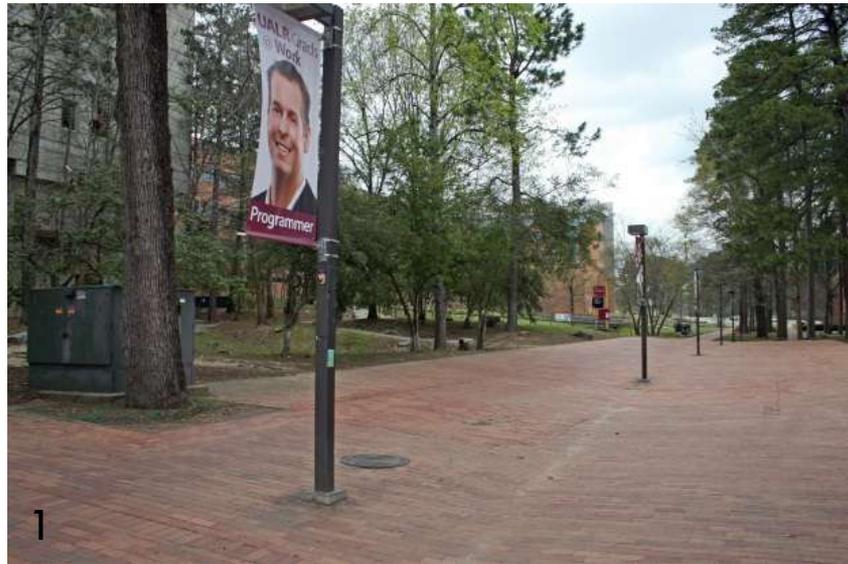
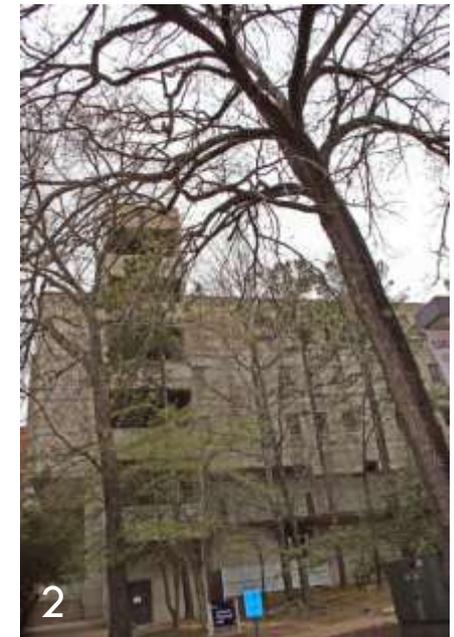
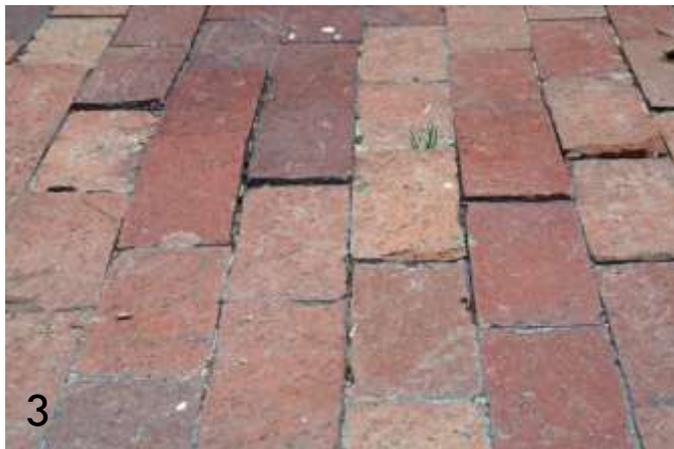
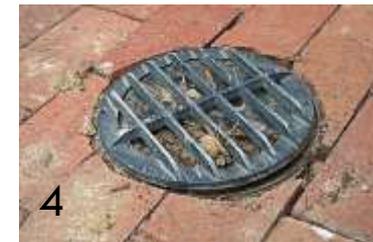
West Side Obstacles

1. Light posts with banners located in the middle of walkway
2. Tree located in walkway on west side of library
3. Uneven brick pavers
4. Flood lamp sticking up from walkway
5. Manhole cover not flush with walkway

- Raise banners on light posts so that an individual does not run the risk of colliding with the horizontal arm sticking out with the banner.
- Place a horizontal stripe of high-contrast tape at approximately eye level on light posts for easy detection.
- Maintain routine trimming service on trees near walking path to ensure trees do not produce heavy shading over walkway.
- Sand protruding bricks to create a level walking surface.
- Paint manhole and flood light covers with high-contrast paint to make obstacles more visible.

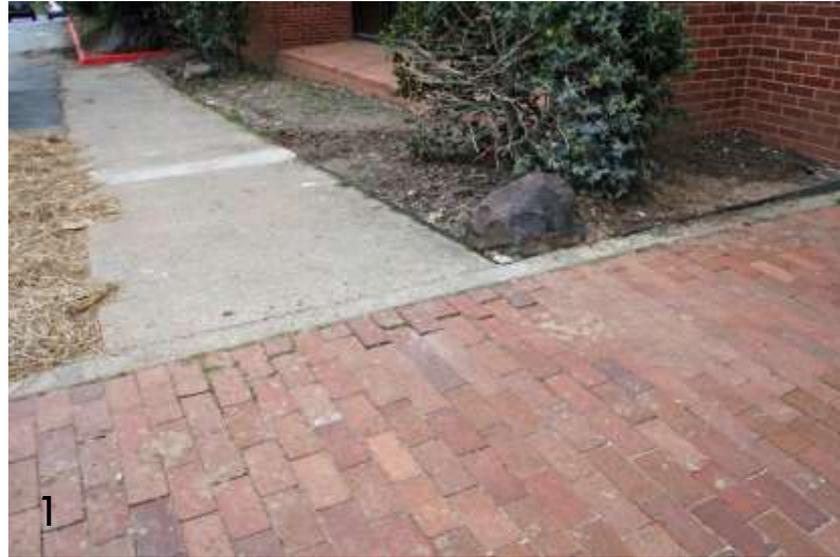
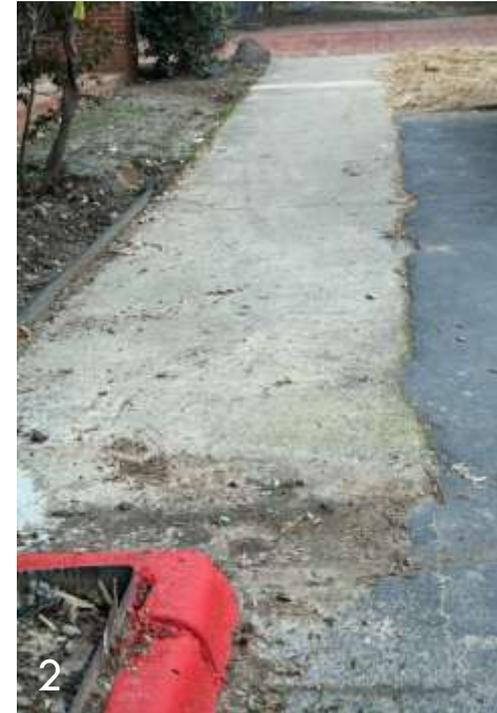
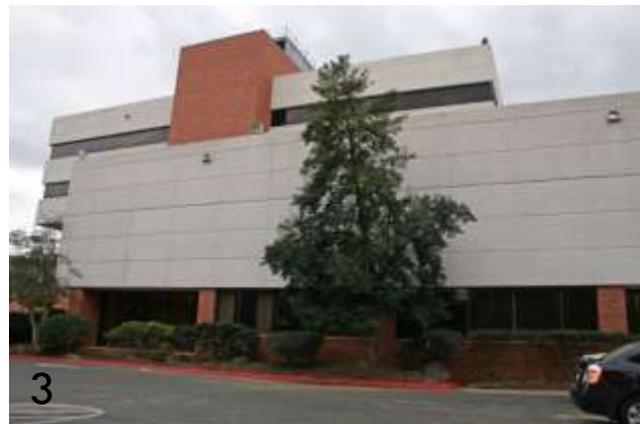
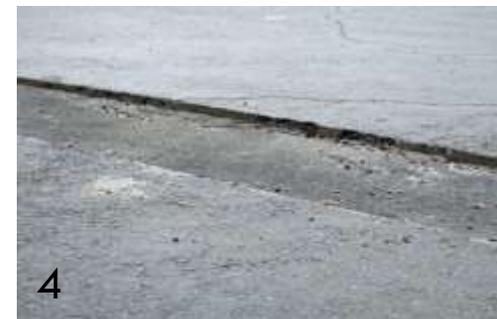
North Side Obstacles

1. Uneven transition from brick to concrete path
2. Concrete sidewalk coming to a dead end at parking lot
3. Immediate surroundings of the north side of the library and parking area
4. Uneven asphalt in parking lot

- Create a distinct walk path for individuals traveling on the north side of the library for avoidance of obstacles.
- Repair existing concrete sidewalk and asphalt to ensure a level, safe surface.

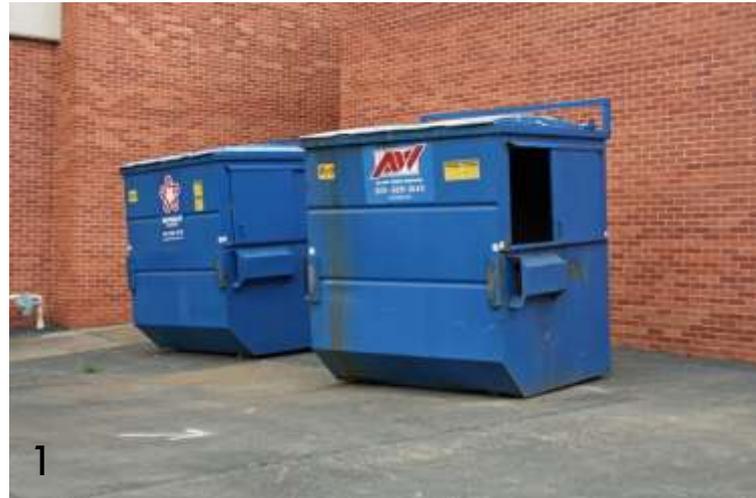
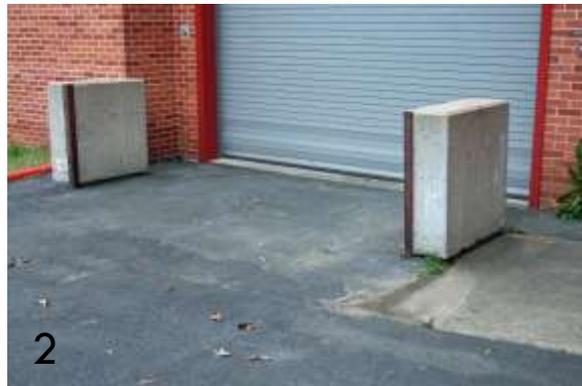
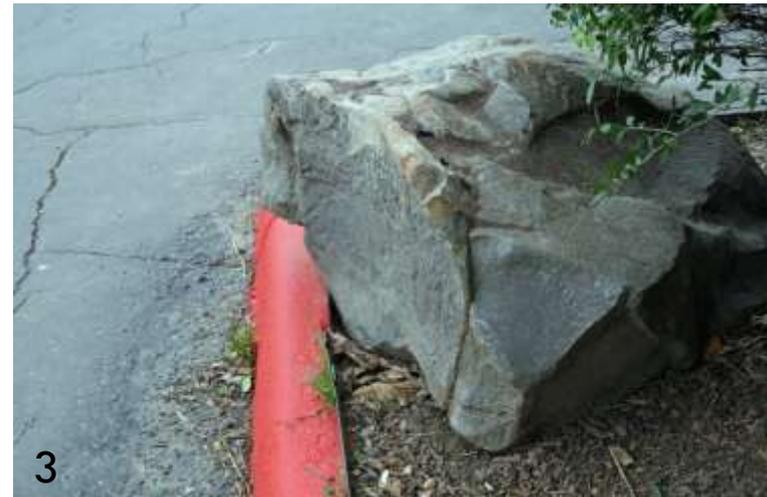
North Side Obstacles Cont.

1. Trash dumpsters sitting away from building
2. Concrete slabs flanking loading zone
3. Rock protruding into walkway

- Create a distinct walk path for individuals traveling on the north side of the library that avoids major obstacles like trash dumpsters that are placed away from the buildings' exterior walls.
- Paint concrete slabs around loading dock a high-contrasting color.
- Move boulders further into flowerbeds so they are not protruding past curbing.

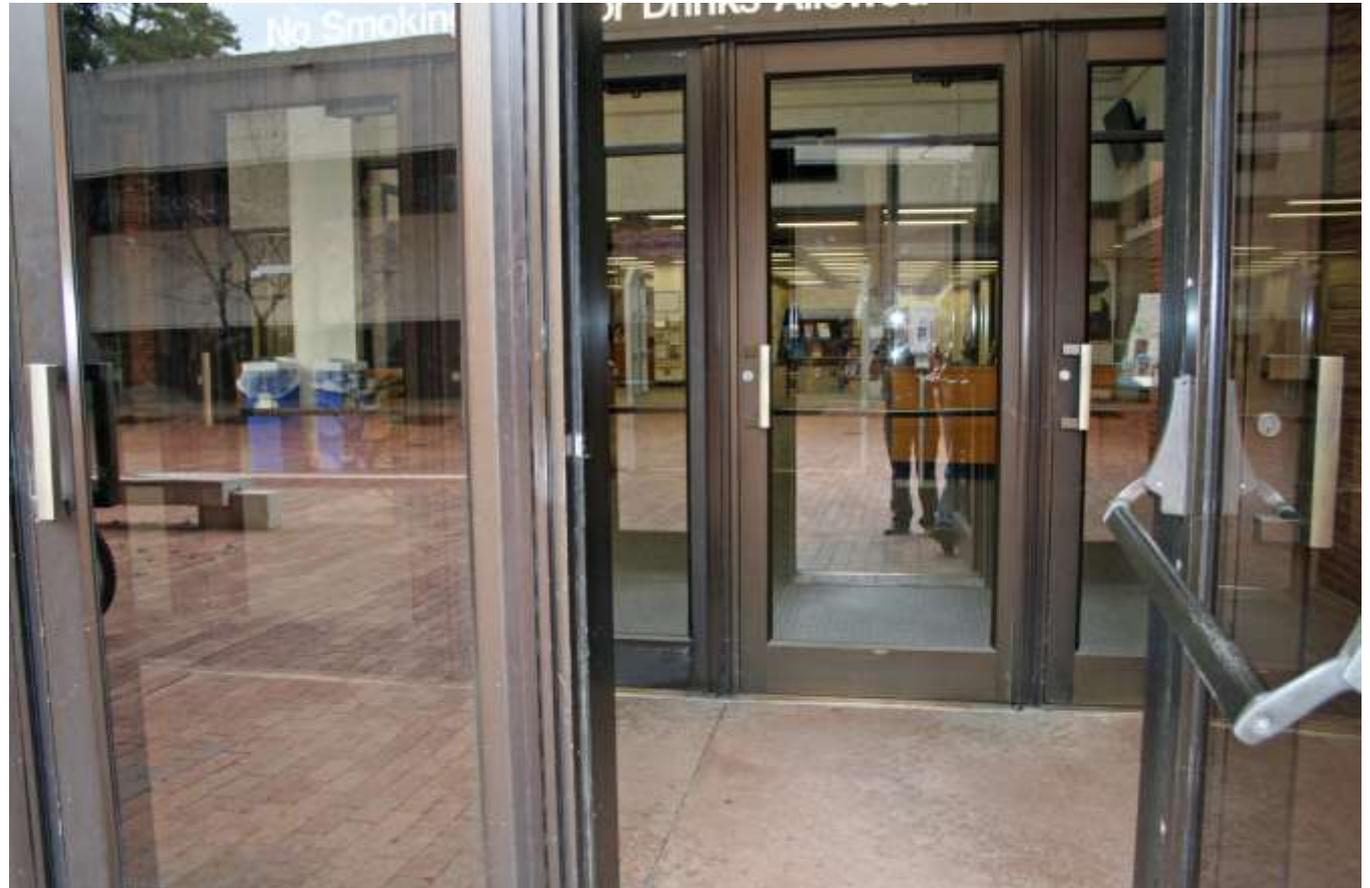
Glass Door Glare

Glare is strong on front entry doors as shown in image right on the library's south side.

- A horizontal stripe should be added to the first and second set of front entry glass doors so that individuals with limited vision can easily detect the presence of glass doors.
- Mats should be placed in front of the doors so that the pathway the door travels can be readily determined.
- Large rugs should be placed from front entry doors to detectors to show the proper travel path one should follow.
- Detector opening should be wider to allow for increased room for navigation.
- High-contrast tape should be placed along the edges of the detectors to allow for clear detection.

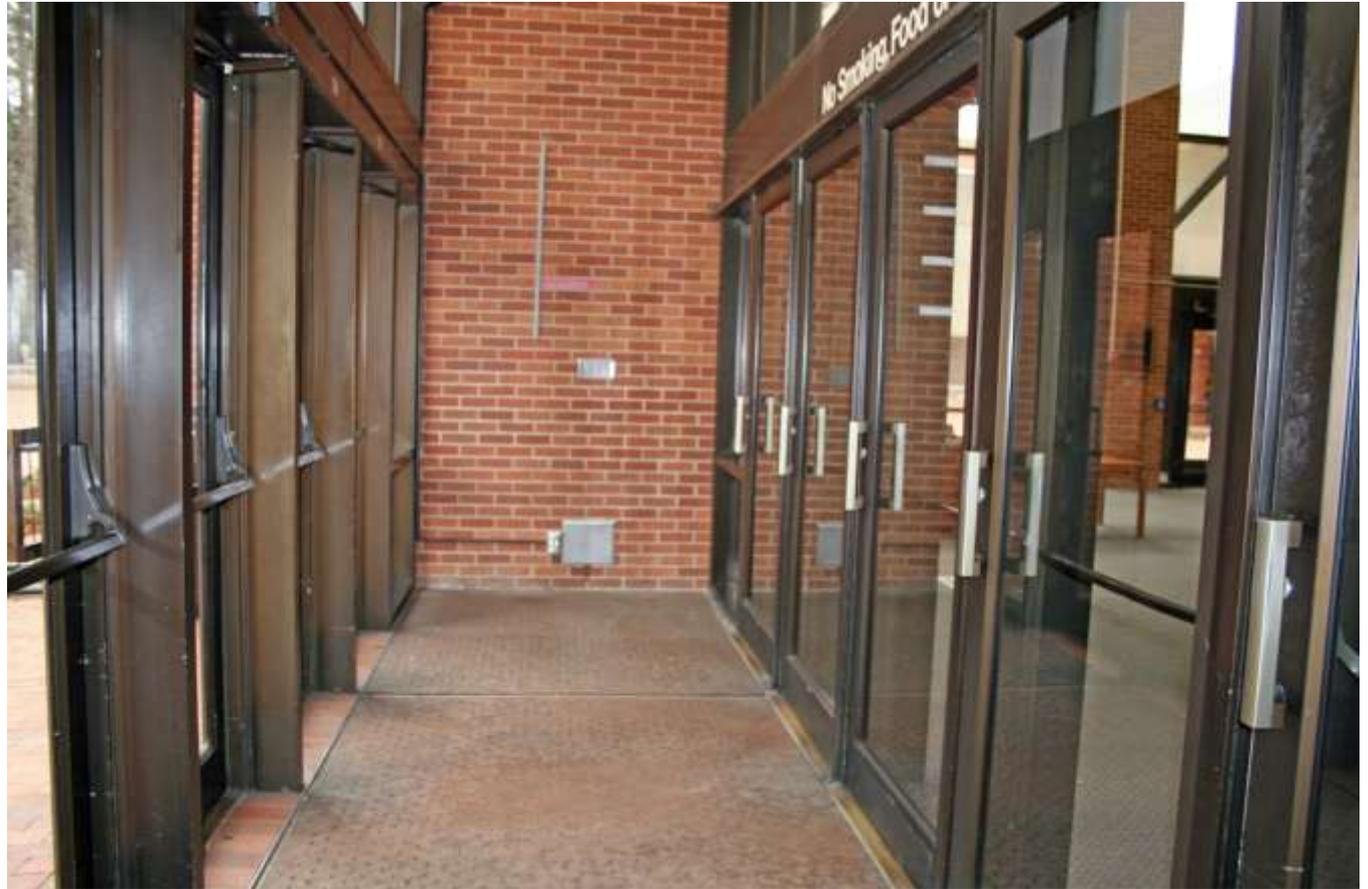
Door Pathways

Door pathways are not marked and glare makes it difficult to detect a second set of doors at the south entry.

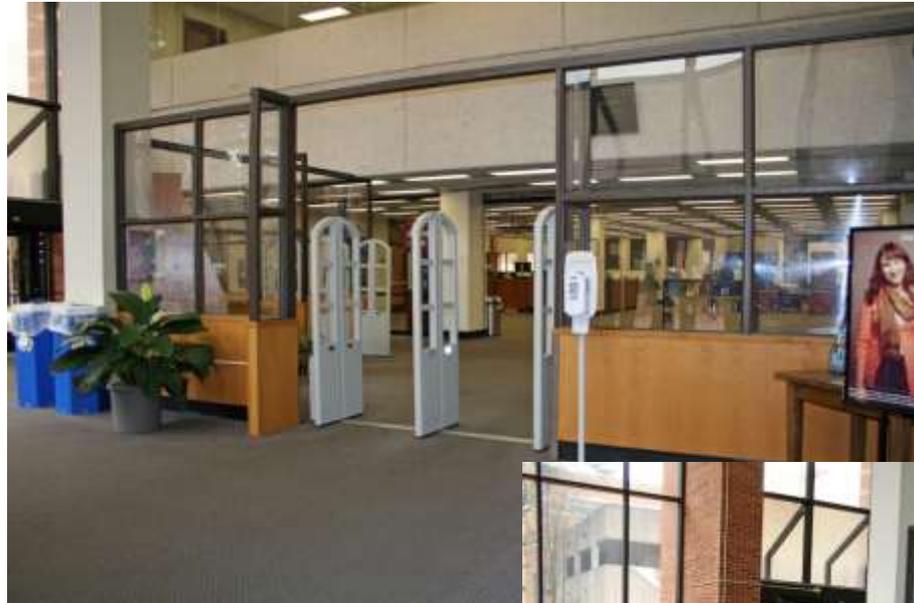
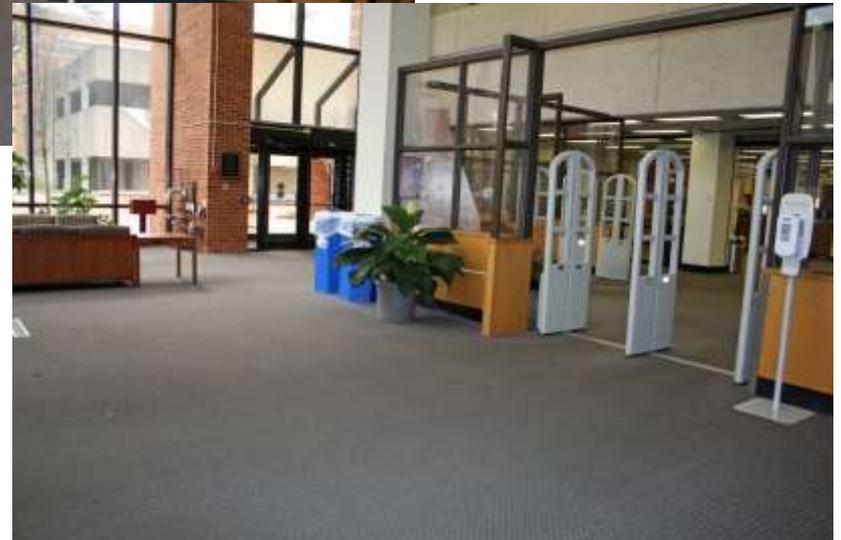
Travel Path

Once through the two sets of doors, you arrive at a large wide open lobby area. To enter the library, you must travel through a narrow portal between the detectors. The layout makes it difficult to determine where to go. Neutral colored detectors are difficult to detect.

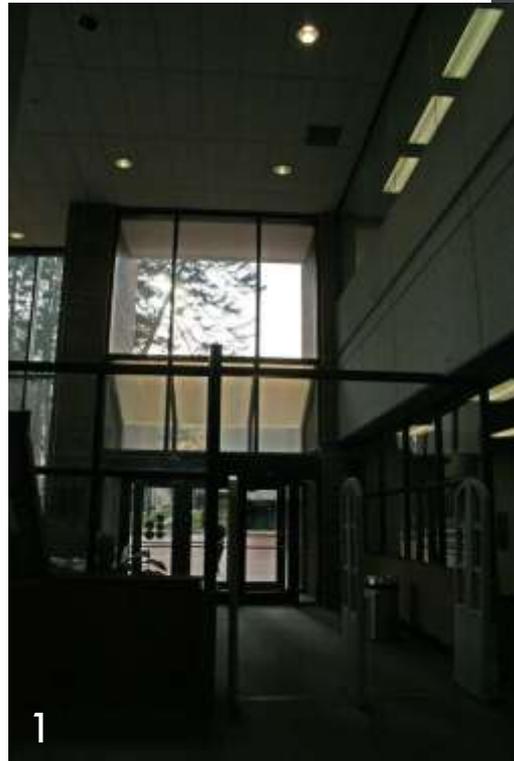
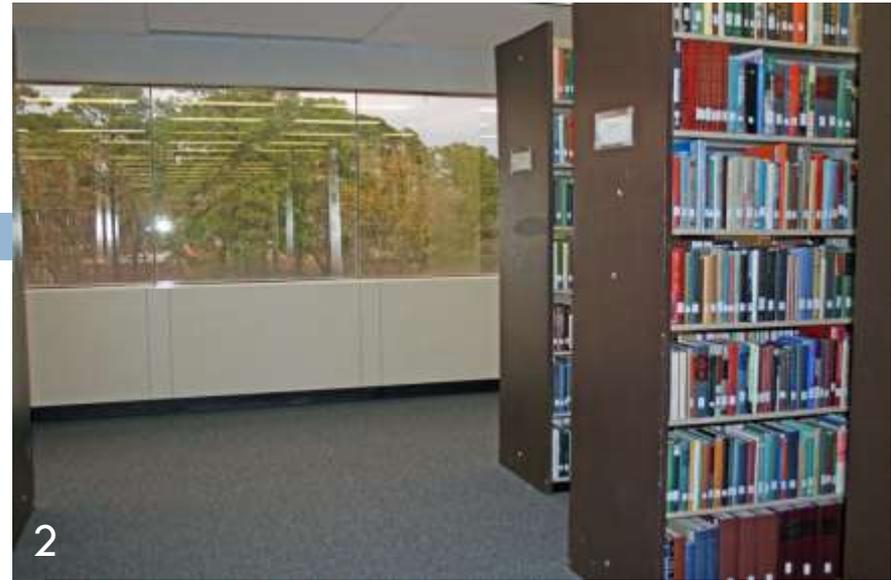
Natural Sunlight

Numerous windows surround the building producing a large amount of natural sunlight; however, it also produces a lot of glare. A large amount of seating is located around these windows casting a lot of glare.

1. Light streaming through front lobby windows
2. Windows surrounding the outer walls of the fourth floor

- Update lighting fixtures to accommodate more natural lighting.
- Lower overhead lighting on north end of main level to increase illumination.
- Provide desk/task lighting at study tables.
- Place blinds or shades on all windows (except on the fifth floor that already has blinds) that can be pulled down to reduce glare.

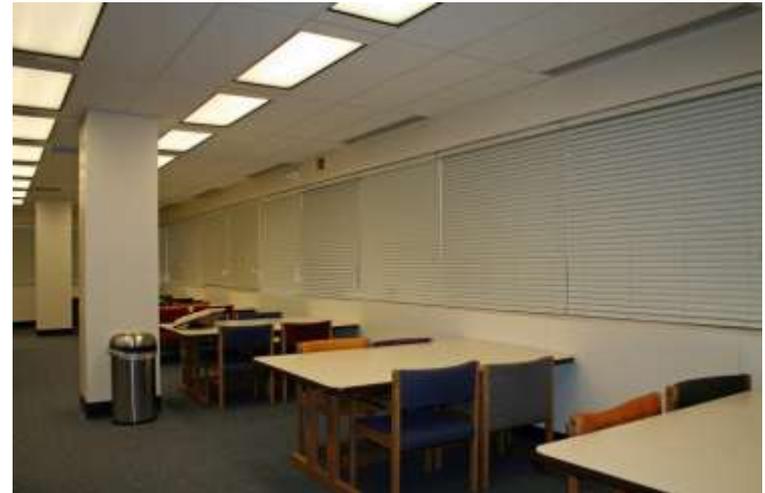
Picture shows blinds located on fifth floor windows. All other windows throughout facility lack window coverings.

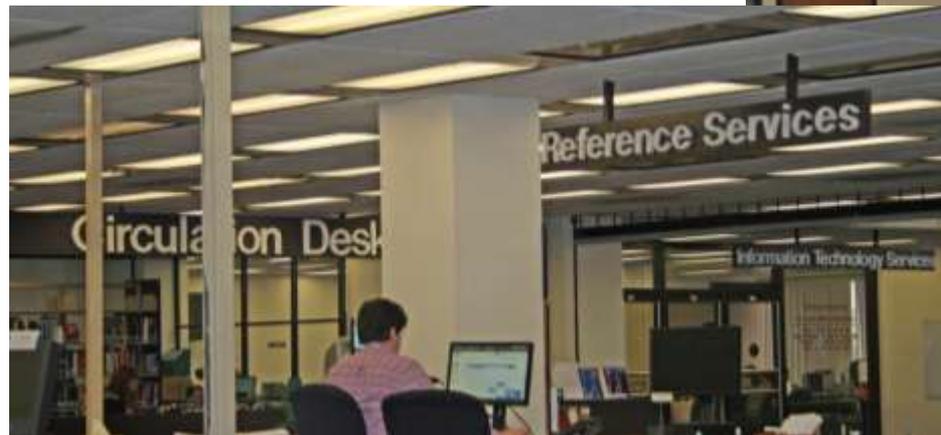
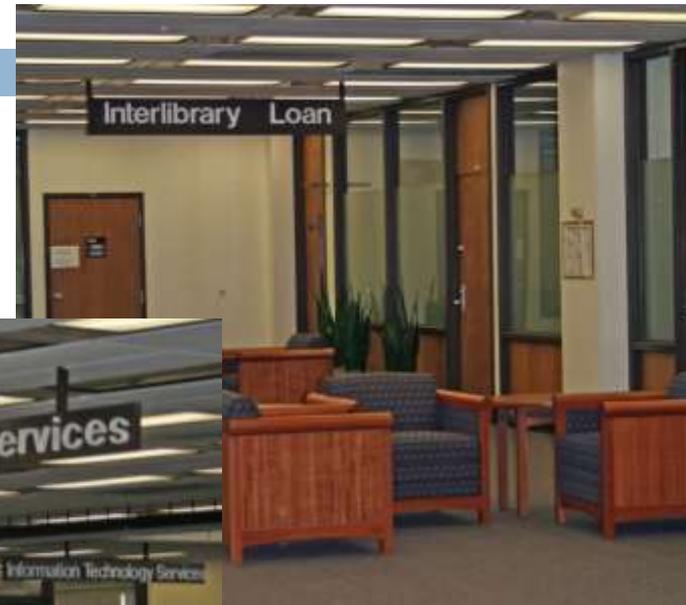
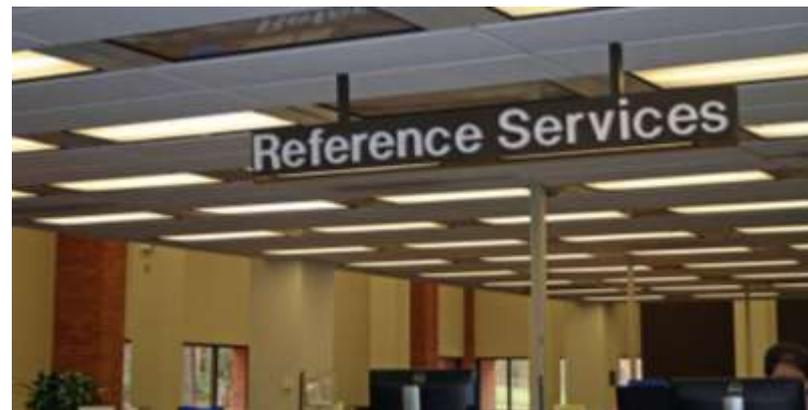
First Floor Overhead Signage

As shown in the images above, the library's lower level has high-contrast, matte finished, large print overhead signage to designate various sections of the floor; however, this is not continued through the remaining floors.

- Add high-contrast, matte finished, large print overhead signage, consistent with the first floor, throughout the entire facility to designate its various sections.
- Provide overhead signage outside elevator doors indicating what you will find on each level.

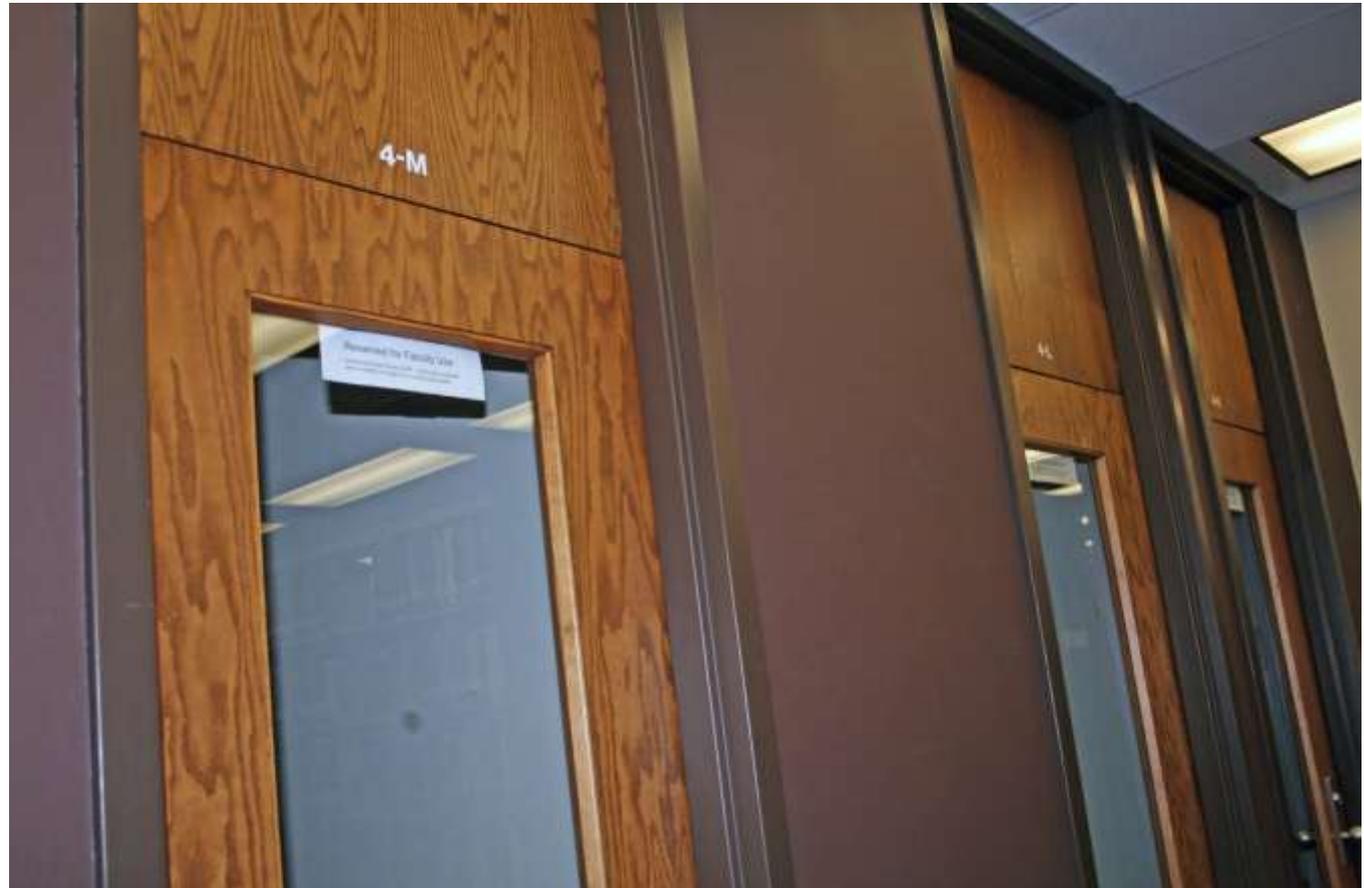
Room Numbers

Small white room numbers above doorways are small, making them difficult to read. Picture depicts room numbers above study rooms located on the fourth floor.

- Repaint larger room numbers above doorways.
- Add consistently styled signage throughout facility.
- Ensure signage is located at the same height on doors and walls throughout facility.
- Replace highly reflective signage with matte finished signs to aid in increasing readability by decreasing glare.
- Add frosting to glass in door inserts to eliminate glare.
- Modify doors so that their operation is uniform throughout the library limiting confusion on how to open doors for individuals, especially those with low vision.
- Place mats or markings in front of doors to denote the doors' travel paths.

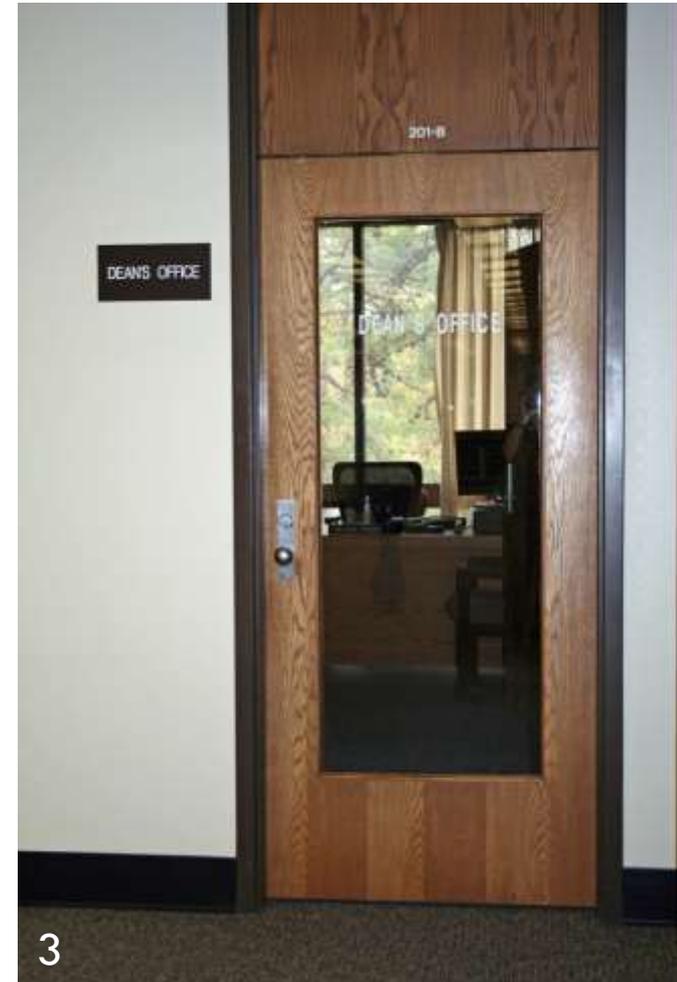
Signage Inconsistencies

Some doors have signs and others do not. Some signs are placed on the wall while others are placed on the door itself. Pictures 1 and 2 depict offices located on the first floor. Picture 3 represents the dean's office on the second floor.

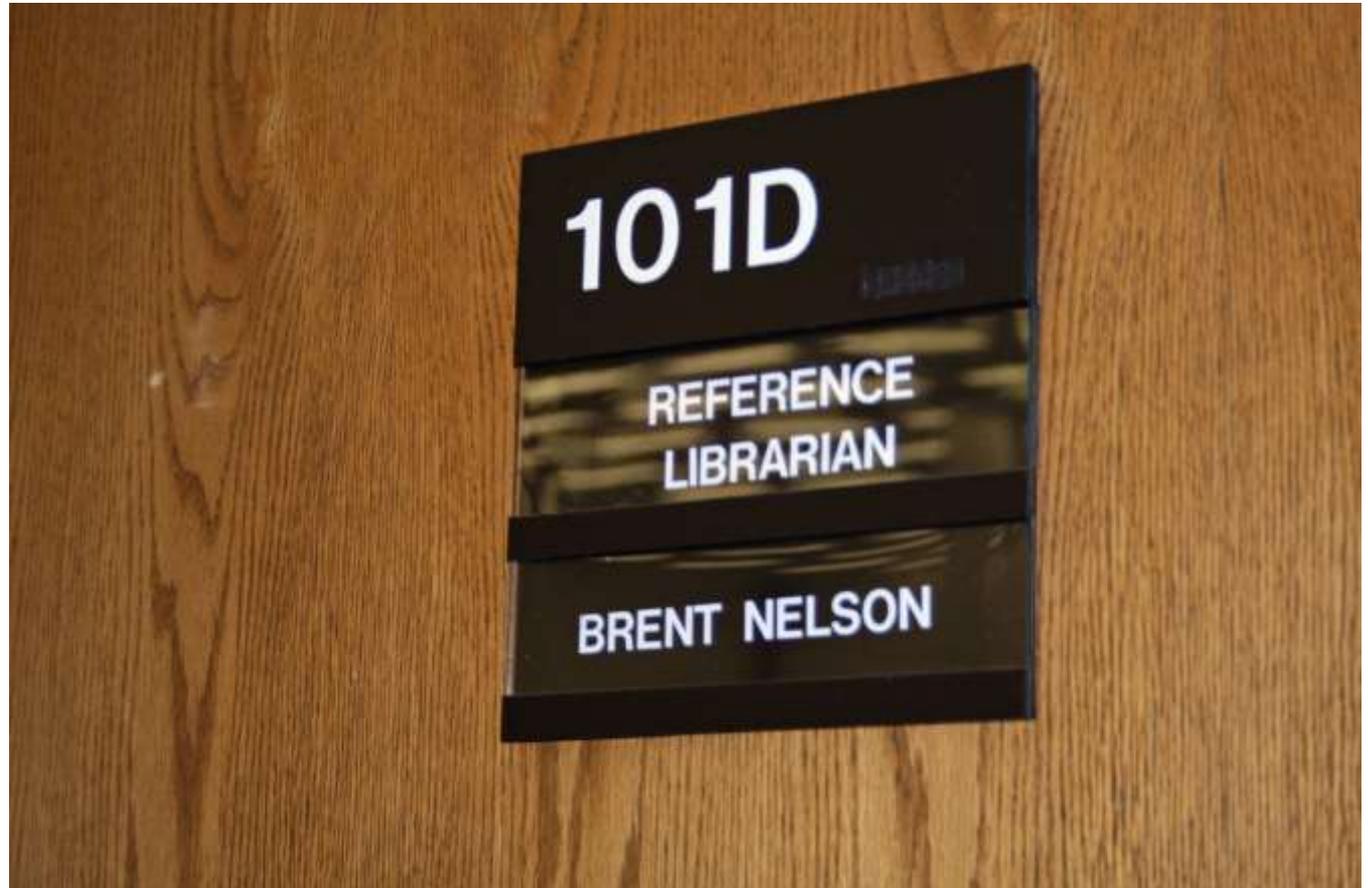
Signage Glare

Overhead lighting reflects in the sign placed on this first floor office door making it difficult to read.

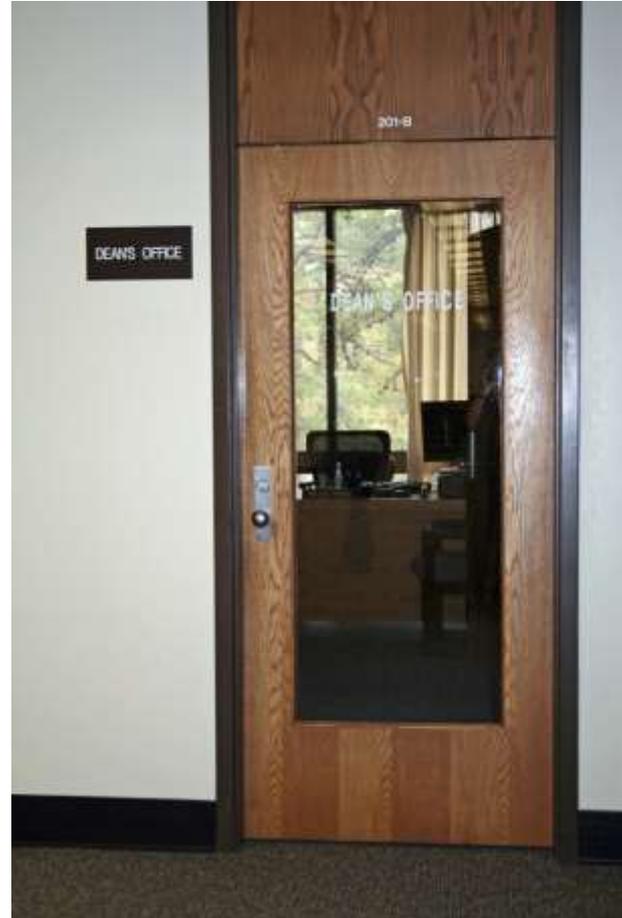
Door Glare

Glare on this second floor office door makes detecting the door and reading its writing very difficult. In contrast, the sign to the left of the door has a matte finish and is easy to read with high-contrast block lettering.

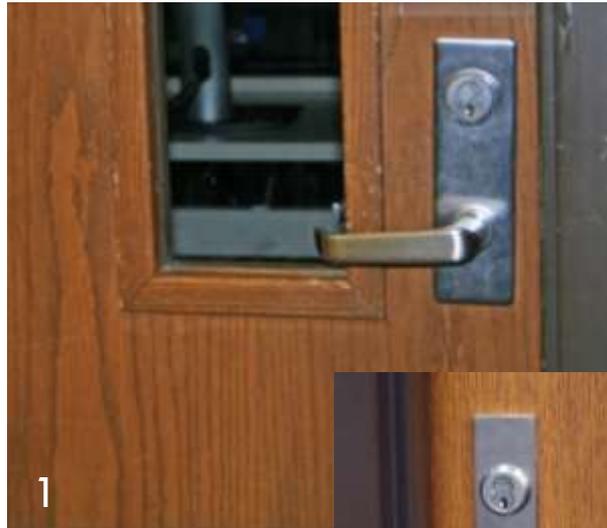
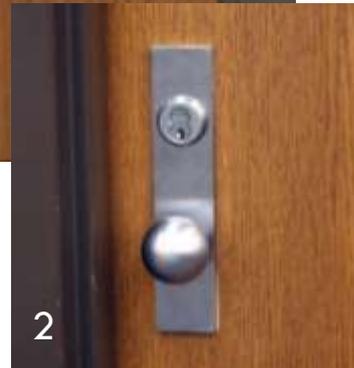
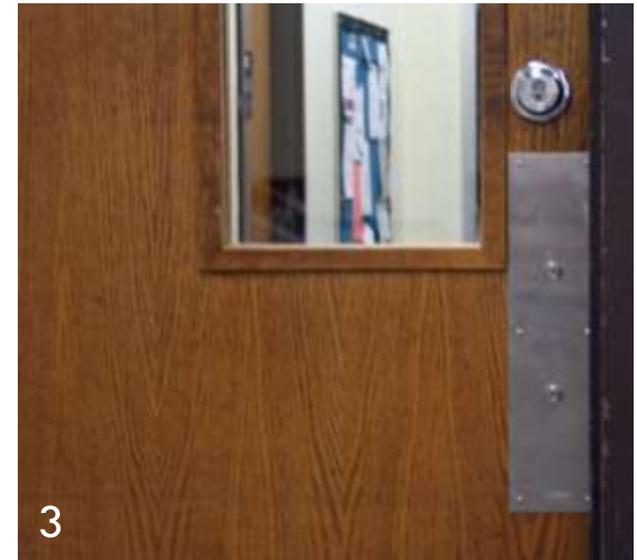
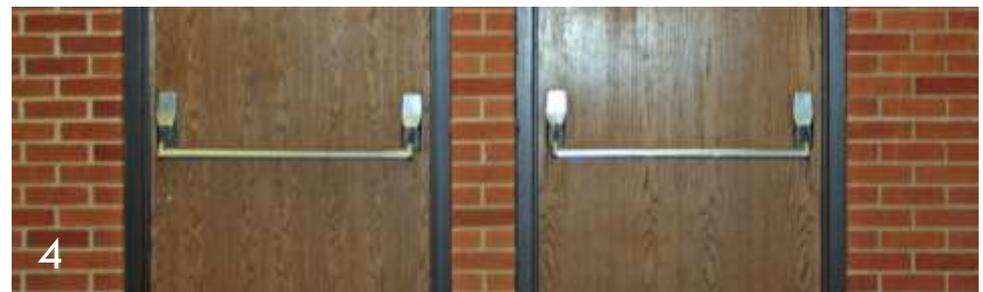
Door Operation Differences

Throughout the facility, interior doors vary in operation. Doors range from having handles, knobs, bars, and push plates. Pictures depict inconsistencies found in first floor offices (pictures 1-3) and emergency exit doors (picture 4).

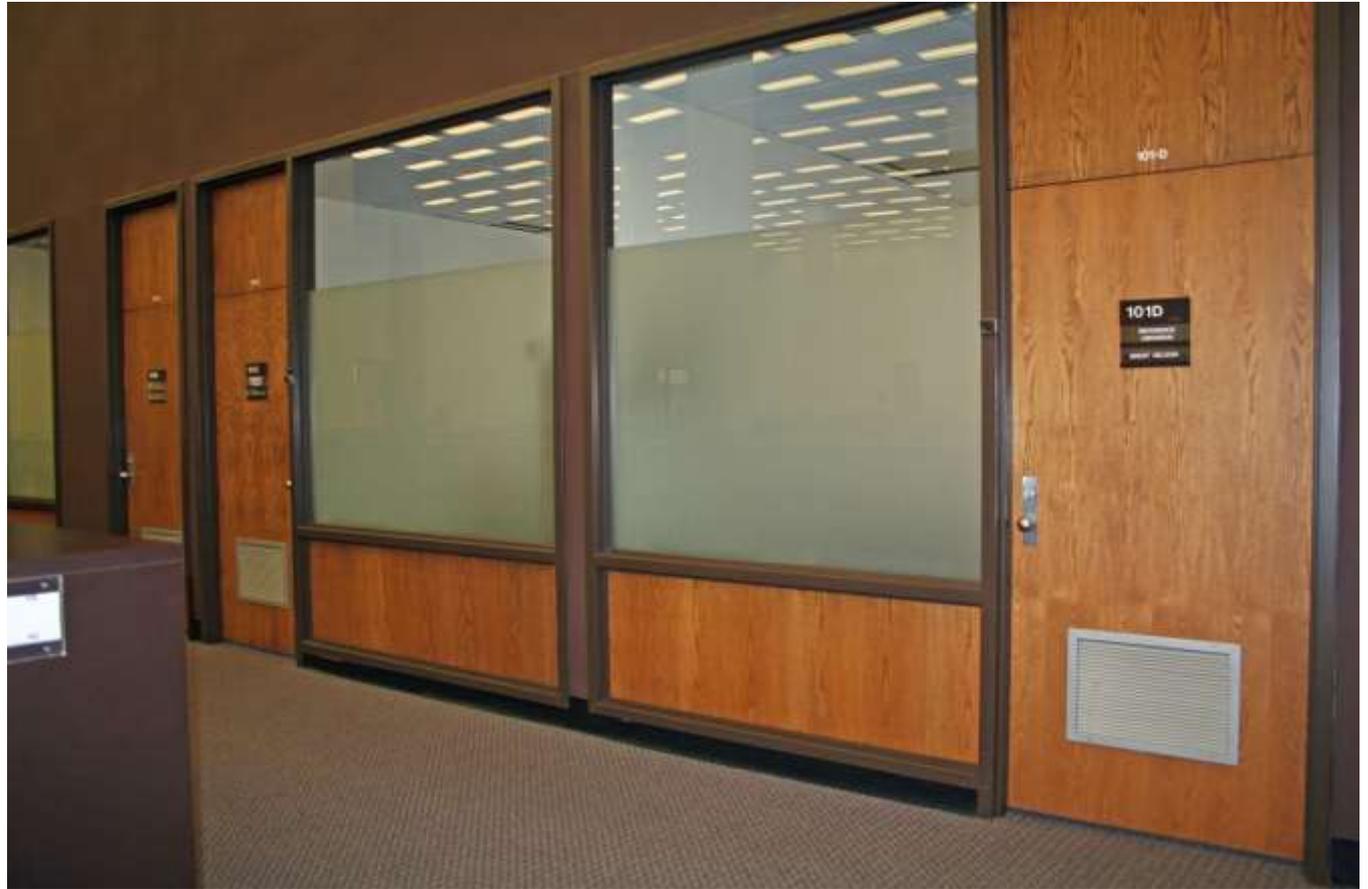
Door Pathway

Doorways throughout the library do not have any markers for the path the door travels when opening and closing. Most doors, however, do open into the offices and not out into the public walkway. Image depicts offices on level one.

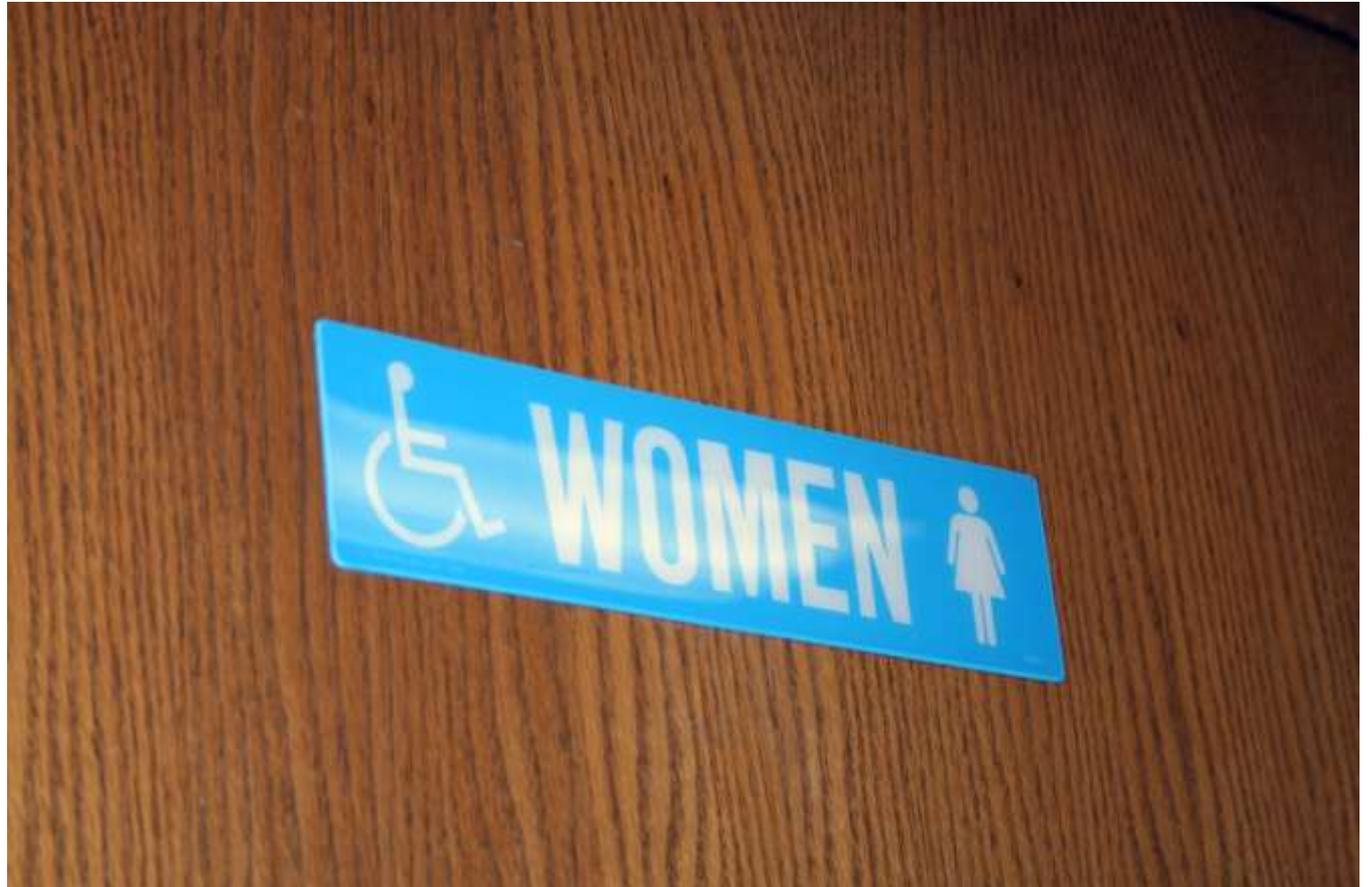
Restroom Signage Glare

While some levels' restroom signs have a matte finish, glare was especially noticeable on the third floor's signs. Photo depicts glare from overhead fluorescent lighting on third floor restroom signage.

- Add consistently styled signage throughout facility.
- Ensure signage is located at the same height on doors and walls throughout facility.
- Eliminate highly reflective signage that produces glare making it difficult to read.

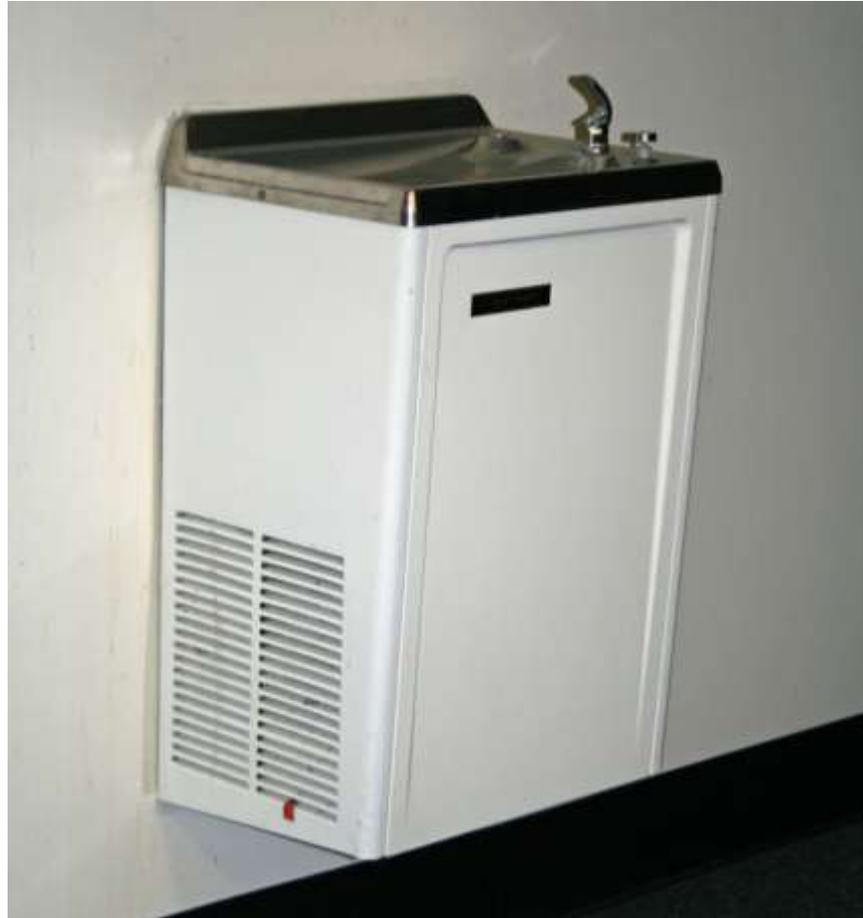
Water Fountains

Water fountains throughout the library, including the fifth floor fountain pictured to the right, blend in with surrounding walls.

- Paint water fountains a high-contrast color. A dark color would stand out against the light colored walls.

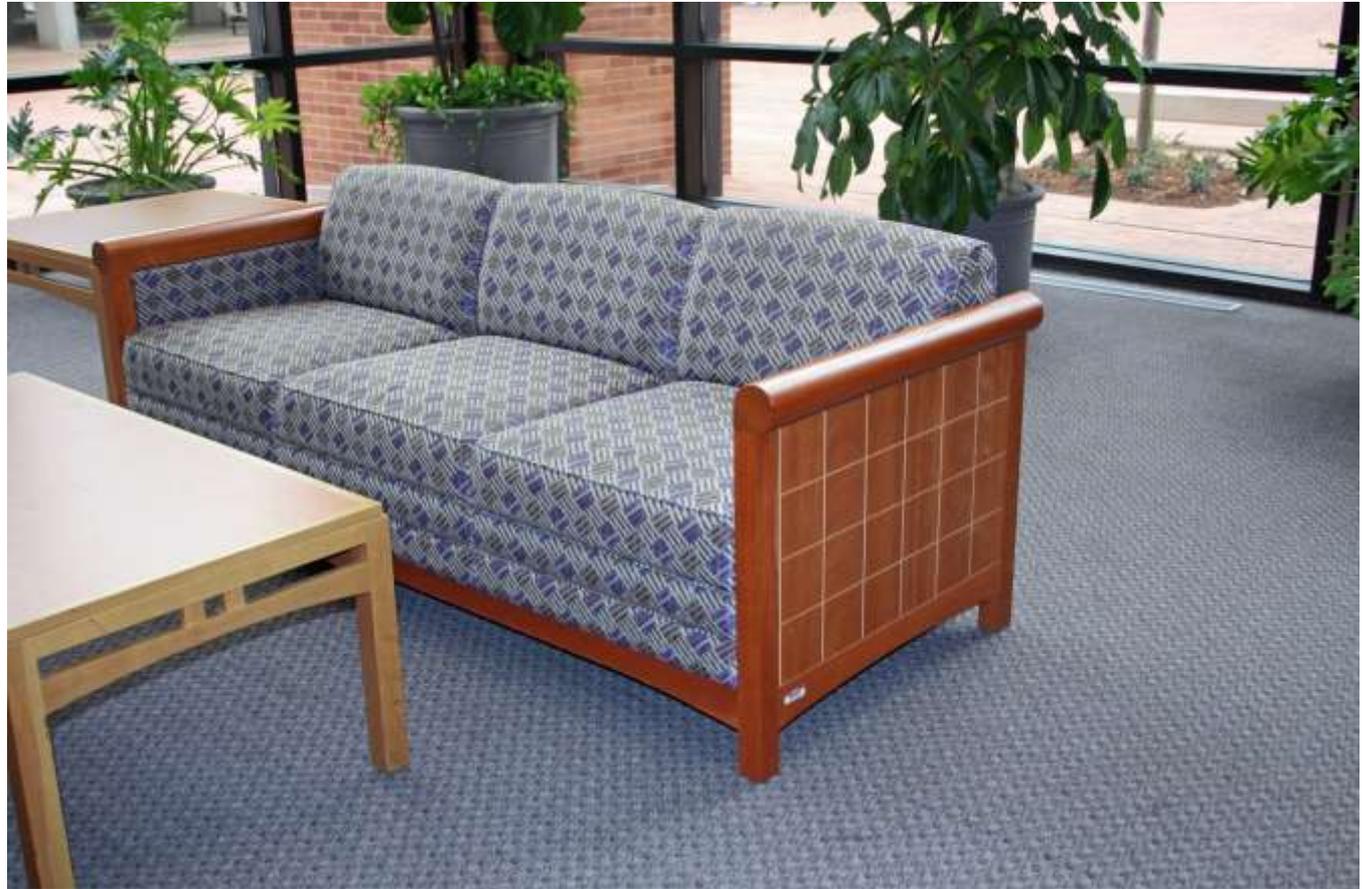
Low Contrast

Upholstered sofa seating located in lobby has similar characteristics as the carpeting. The lack of contrast makes it difficult to localize the lounge seating.

- Change upholstery on furnishings or add contrasting pillows to seating when color is too similar to flooring.
- Add blinds or shades to windows to reduce glare from sunlight reflecting off tables.
