RHBL 7325 ENVIRONMENTAL ANALYSIS

By: Whitney Musick

UALR's Ottenheimer Library

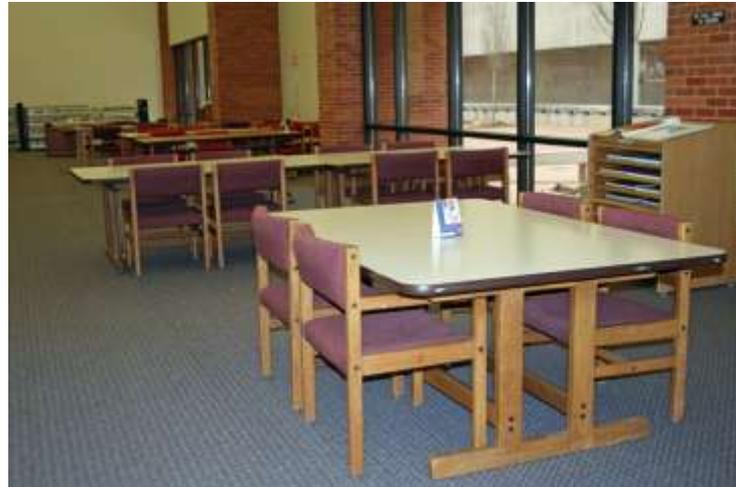
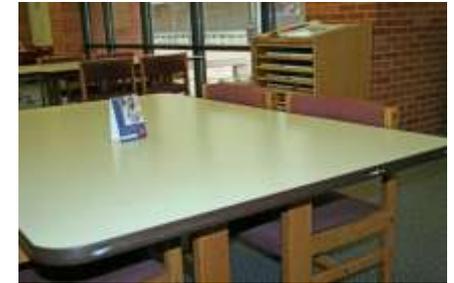
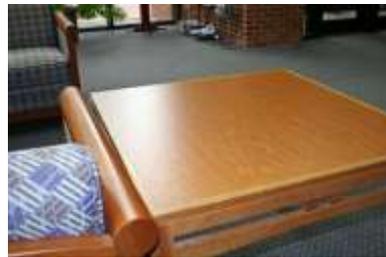
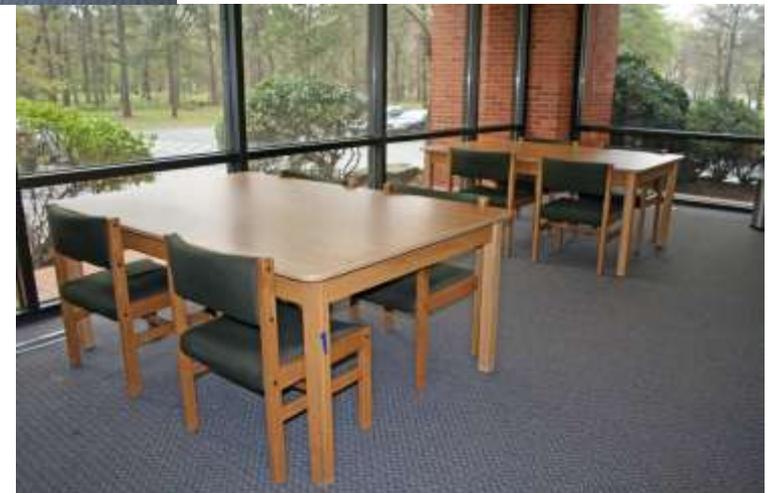
Desktop Glare

Depicted are tabletops located on the lower level of Ottenheimer Library. Throughout the facility, study tables and desktops produce a great amount of glare due to lighting conditions.

- Change upholstery on furnishings or add contrasting pillows to seating when color is too similar to flooring.
- Add blinds or shades to windows to reduce glare from sunlight reflecting off tables.

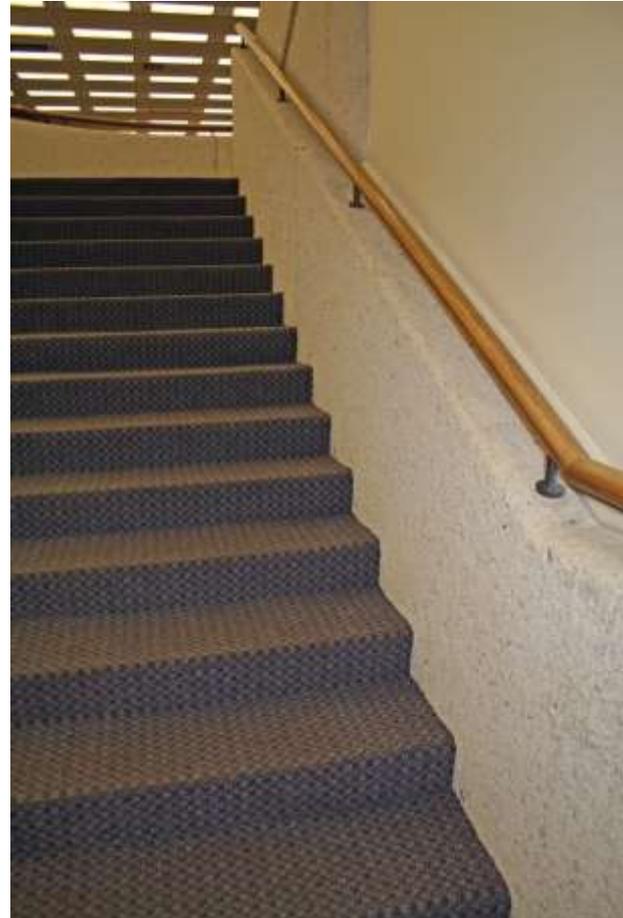
Step Markings

As depicted in the photo, there are no markings indicating the end of each step on the first floor main staircase. The hand rail and high-contrast between the stairs and the wall color, however, are beneficial features.

- Place high-contrast tape at the beginning and end of main first floor stairway.
- Replace flooring in stairwell to a material with less sheen.
- Increase the number of light fixtures in the stairwell to increase illumination.
- Repair or replace fluorescent fixtures that produce flickering light.

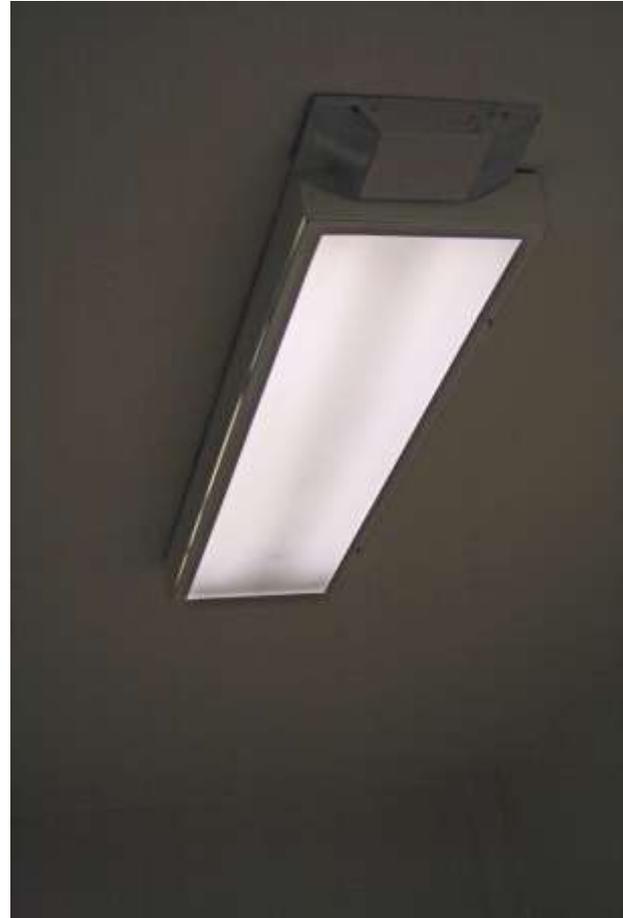
Stairwell Lighting

Lighting throughout the stairwell was poor. The fluorescent fixtures produced dim, flickering light. Image depicts light fixture in the stairwell between the second and third floors.

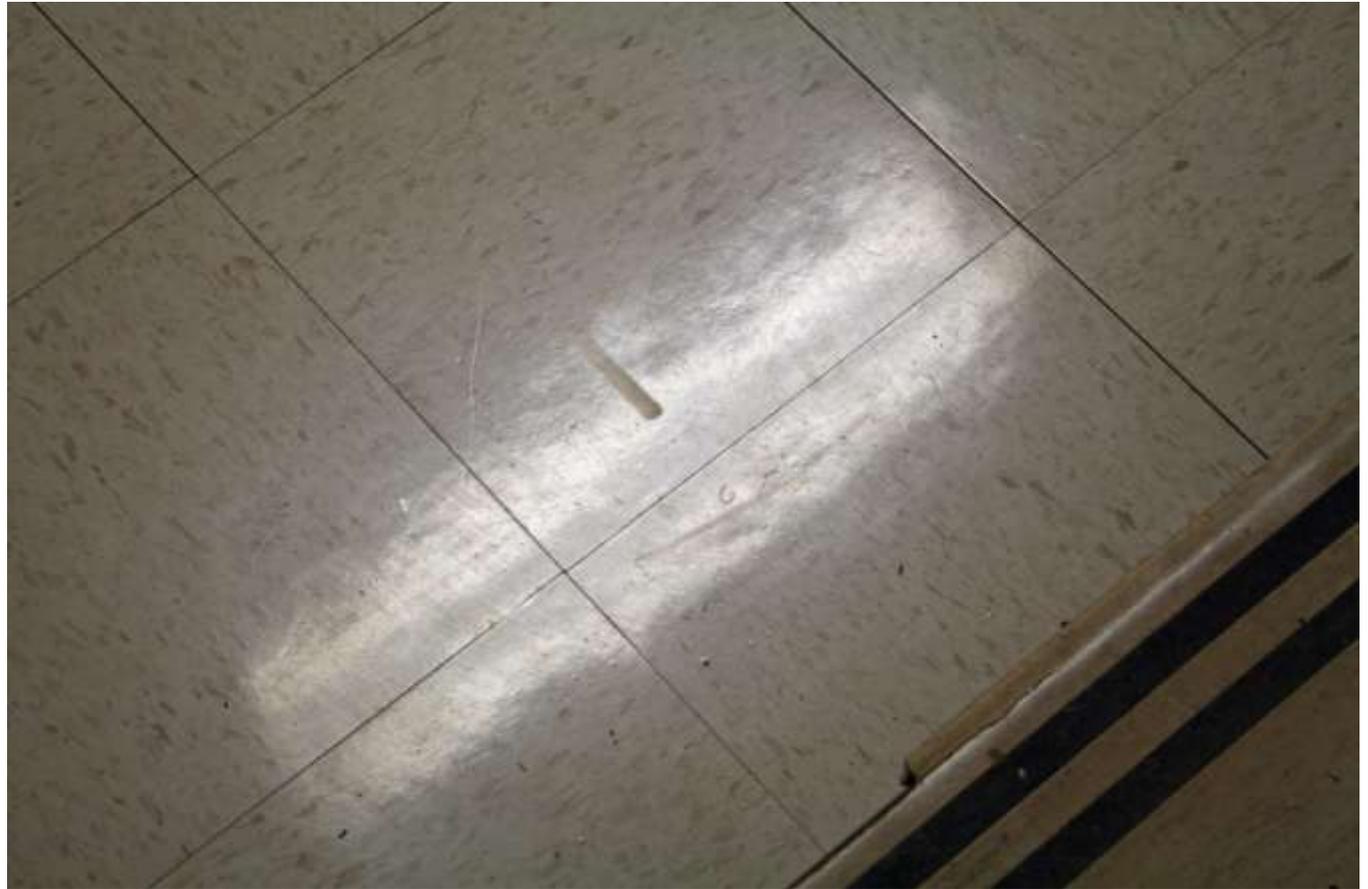
Stairwell Glare

At the end of this third level staircase, you can clearly see the strong glare from the fluorescent lighting on the tile floor.

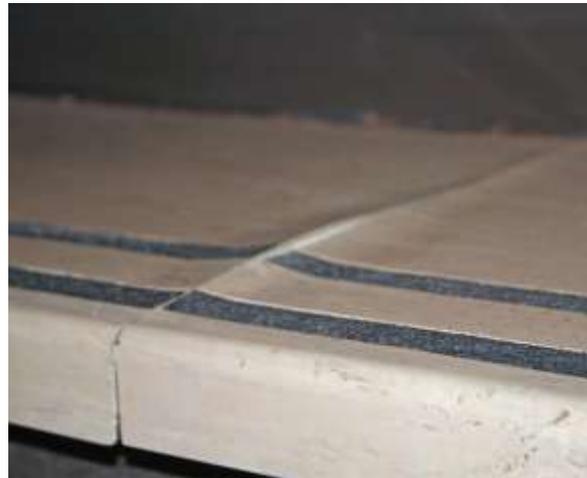
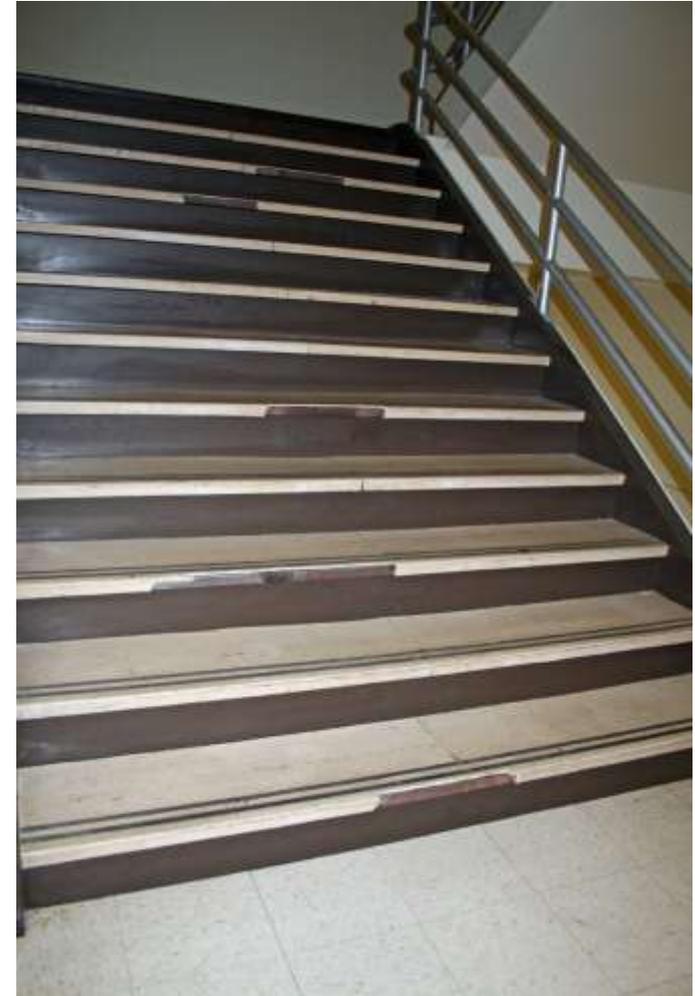
Stair Condition

Places in the stairway are in poor condition creating a tripping hazard if someone is not carefully watching his step. The high-contrast, non-skid tape was a nice safety addition though. Depicted are the stairs between the second and third floors.

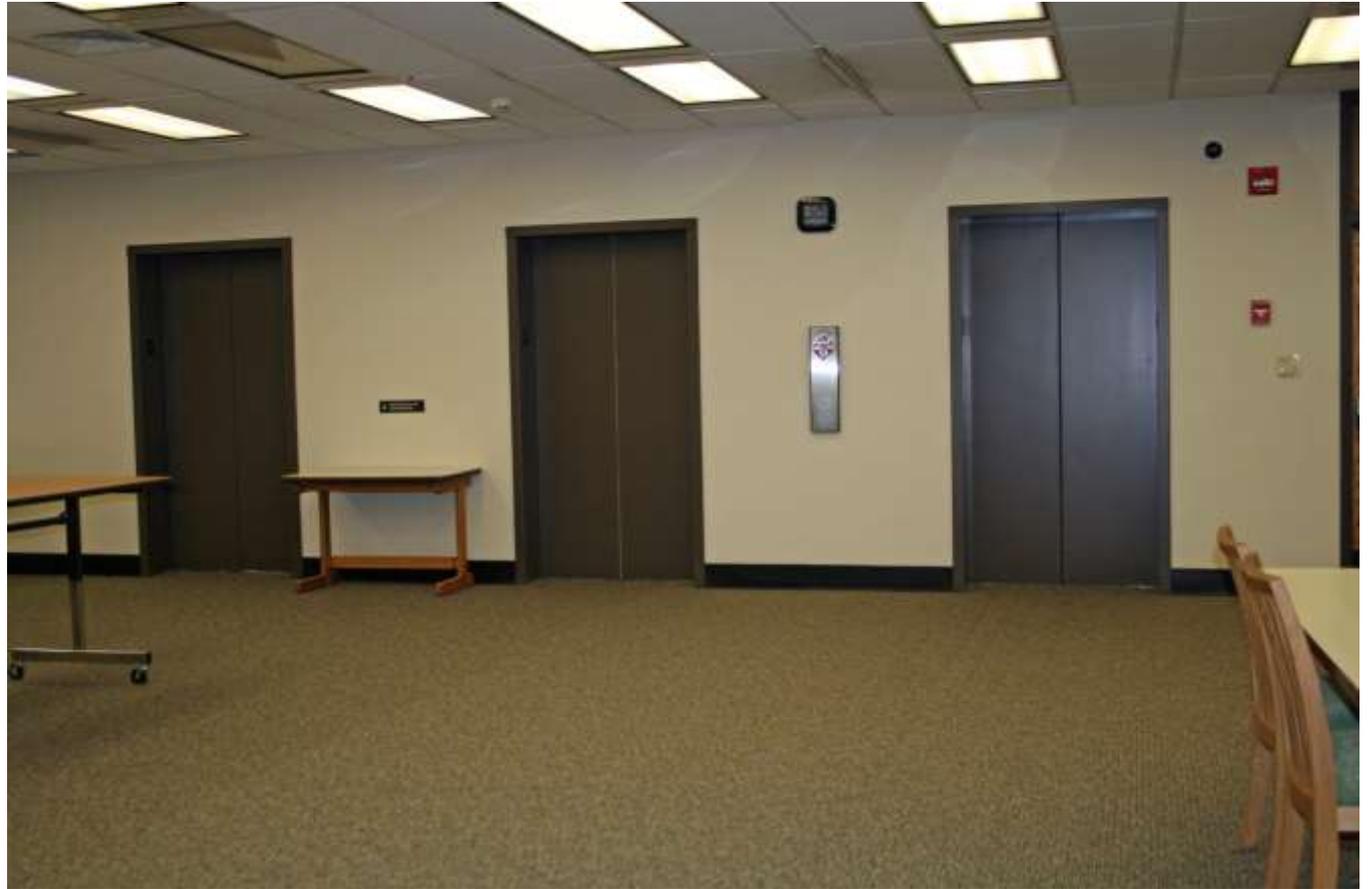
Elevator Signage

Elevators lack signage dictating their location. Depicted are the elevators located on the second level.

- Secure overhead signage near location of elevators.
- Place mats in front of doors as to denote where entry to elevator is located.
- Paint or place yellow non-skid tape to denote transition at elevator door.
- Paint elevator buttons red for easier detection.

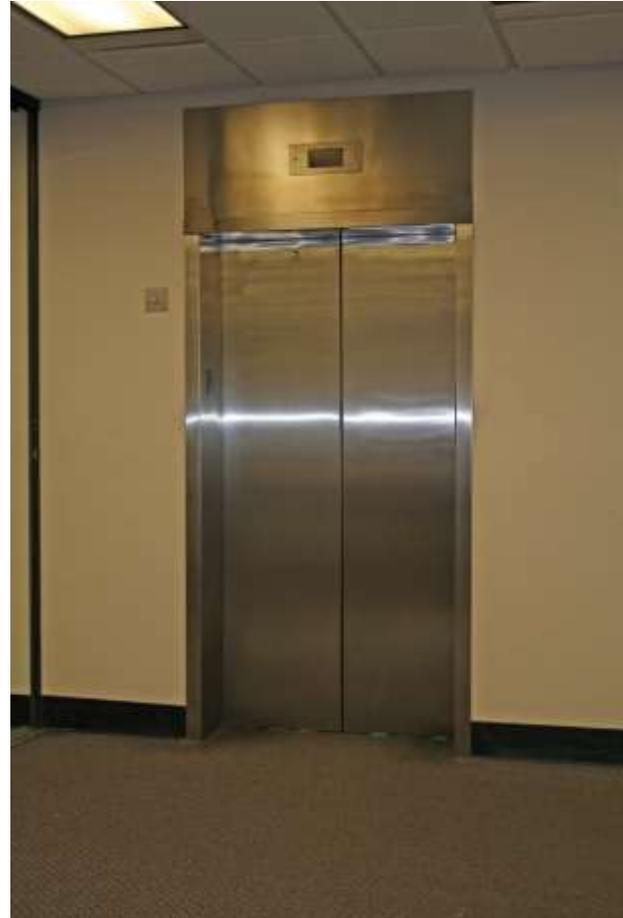
Transition

Pictured first floor elevator door, as with other locations in the facility, do not have any safety markings to indicate the transition from the stationary floor to the elevator.

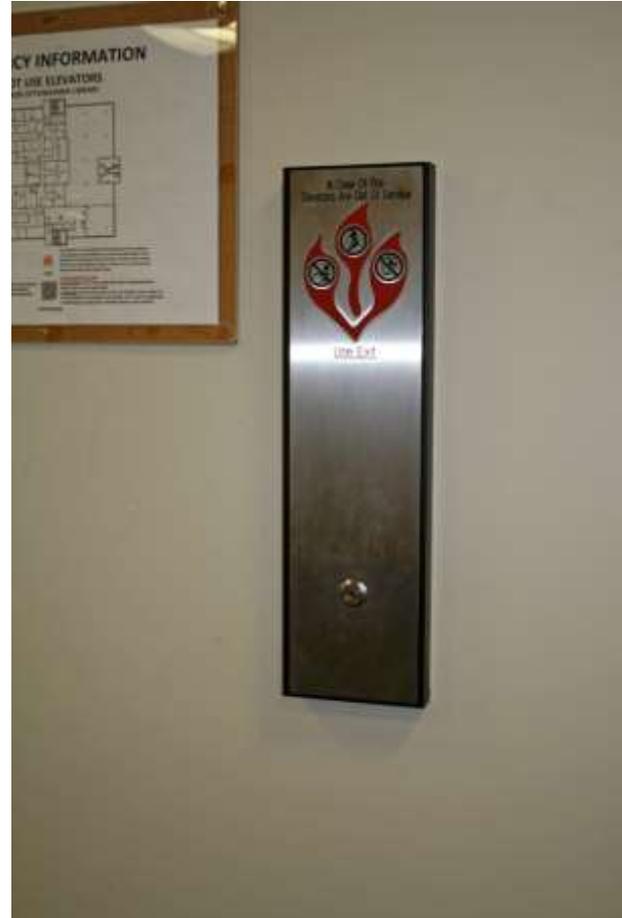
Elevator Buttons

Buttons for elevators are made of a stainless steel like material which produces a lot of shine and glare. Locating the small button on the panel is difficult. Picture is taken of fifth floor control panel.

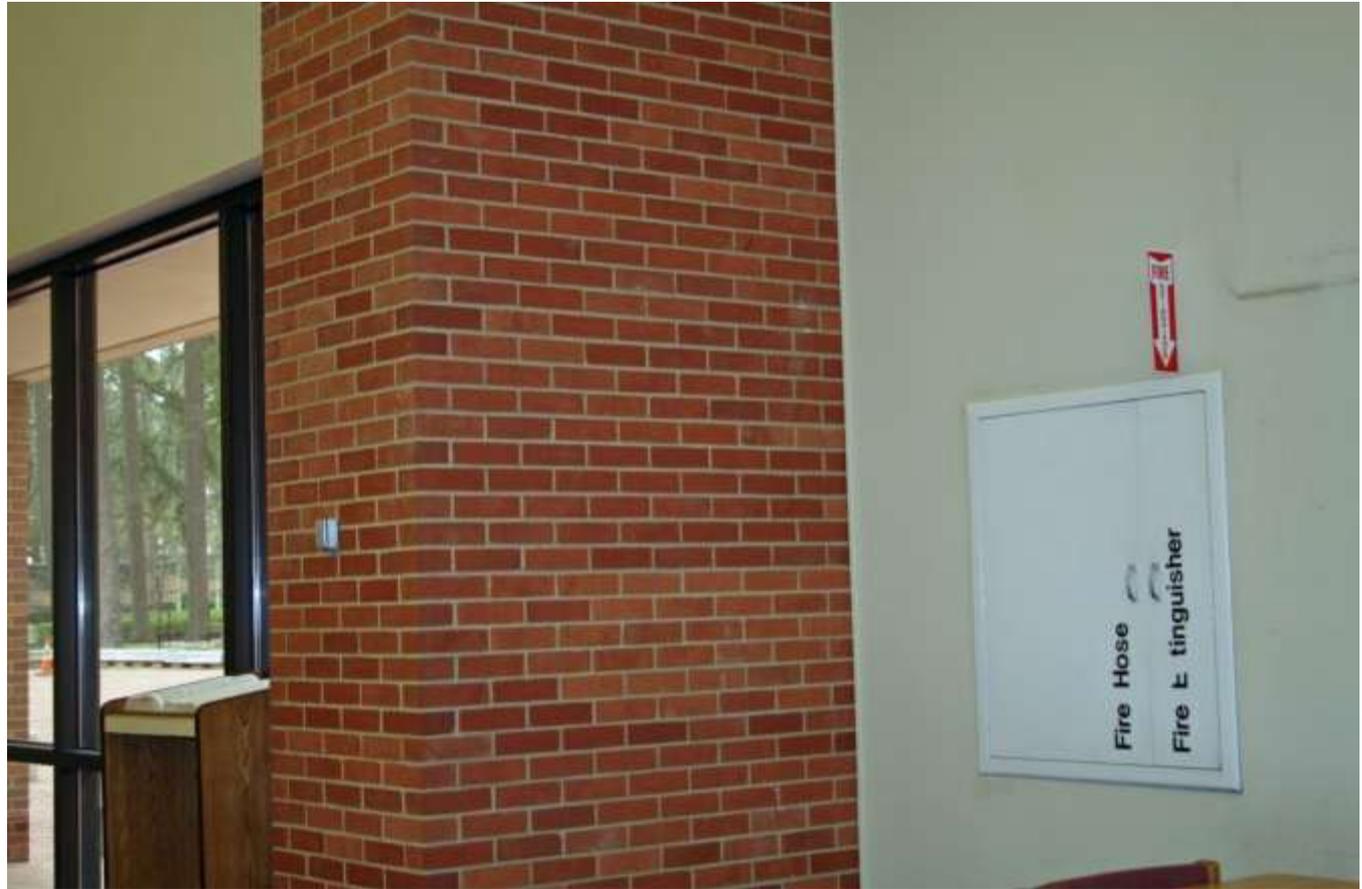
Emergency Tools

Image depicts first floor fire hose and fire extinguisher. The unit blends into the wall and is difficult to spot.

- Paint the trim of the unit in a high-contrast color to ensure good visibility in case of an emergency.
