RHBL 7325 ENVIRONMENTAL ANALYSIS

By: Whitney Musick

UALR's Ottenheimer Library

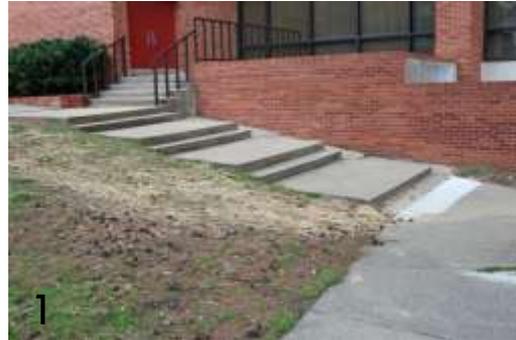
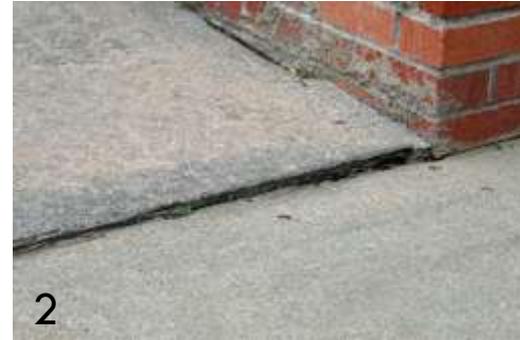
1. Uneven pavement leading to stairs without handrails

2. Close-up of uneven pavement located in front of stairs

3. Concrete cracking at stairs

4. Fading safety stripe

5. Sidewalk with no side barrier

6. Uneven convergence of different textured sidewalks at the southeast corner of the library

- Repair and smooth out imperfections in walkway.
- Add high-contrast non-skid tape to the edge of all steps.
- Repaint and add yellow striping at the beginning and end of stairways.
- Place handrails at each set of exterior stairs that do not have them in place in order to prevent individuals from falling off the side of the steps.
- Build up elevation of ground beside sidewalk with dirt to eliminate drop-off.

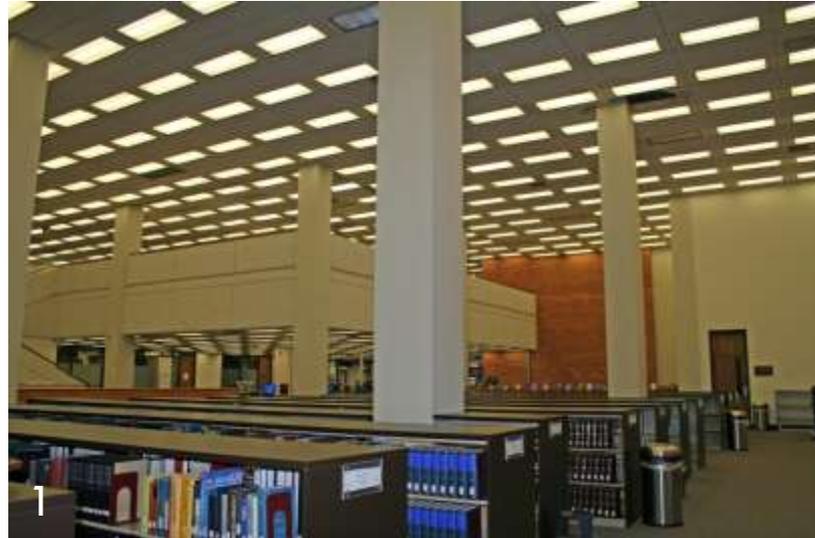
Lighting through the library is fluorescent overhead fixtures. The north end of the main level's lighting is at the same height as the second level. See image 1 for clarity. Throughout the remainder of the building, the fixtures are set at a better height for increased illumination. However, despite the number of fixtures, the facility remained fairly dim.

1. Main floor lighting
2. Second floor lighting

- Update lighting fixtures to accommodate more natural lighting.
- Lower overhead lighting on north end of main level to increase illumination.
- Provide desk/task lighting at study tables.
- Place blinds or shades on all windows (except on the fifth floor that already has blinds) that can be pulled down to reduce glare.

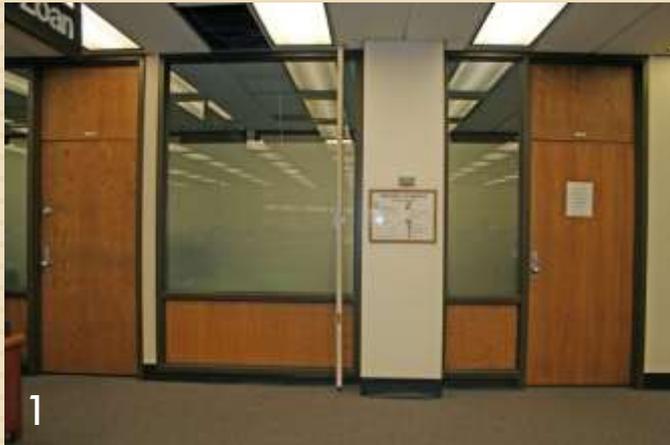
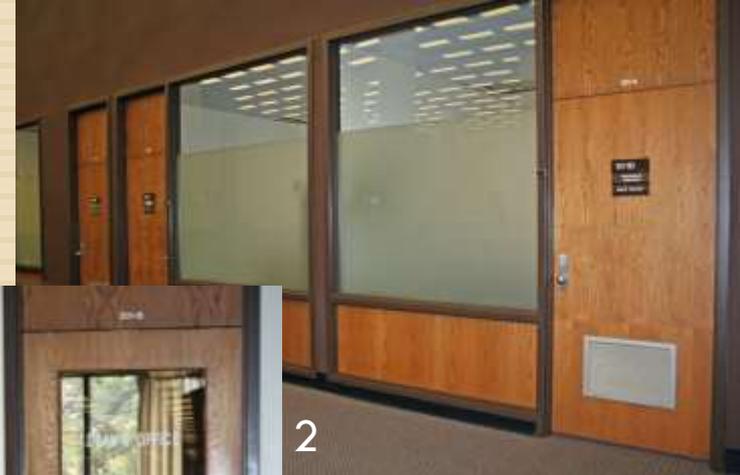
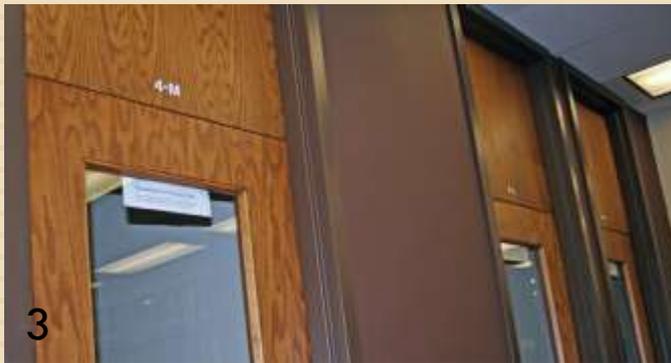
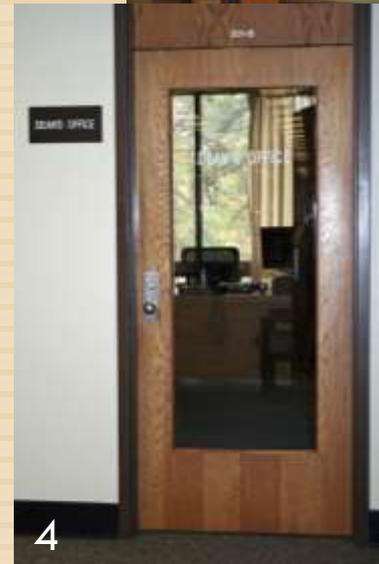
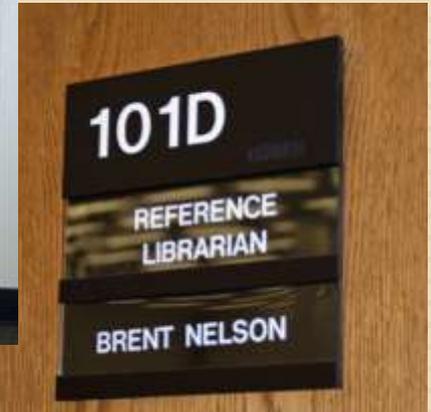
1. First floor offices
2. First floor offices
3. Fourth floor study rooms
4. Second floor dean's office
5. First floor reference librarian's office

Small white room numbers above doorways are small, making them difficult to read. Picture depicts room numbers above study rooms located on the fourth floor.

Some doors have signs and others do not. Some signs are placed on the wall while others are placed on the door itself. Pictures 1 and 2 depict offices located on the first floor. Picture 3 represents the dean's office on the second floor.

- Repaint larger room numbers above doorways.
- Add consistently styled signage throughout facility.
- Ensure signage is located at the same height on doors and walls throughout facility.
- Replace highly reflective signage with matte finished signs to aid in increasing readability by decreasing glare.
- Add frosting to glass in door inserts to eliminate glare.
- Modify doors so that their operation is uniform throughout the library limiting confusion on how to open doors for individuals, especially those with low vision.
- Place mats or markings in front of doors to denote the doors' travel paths.

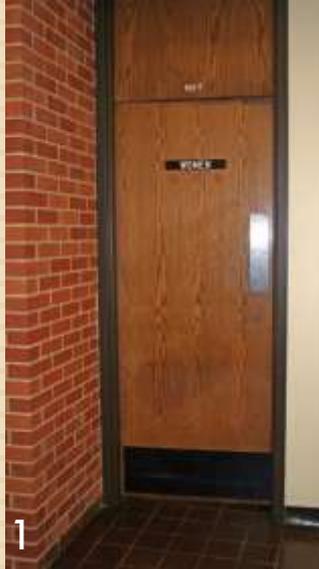
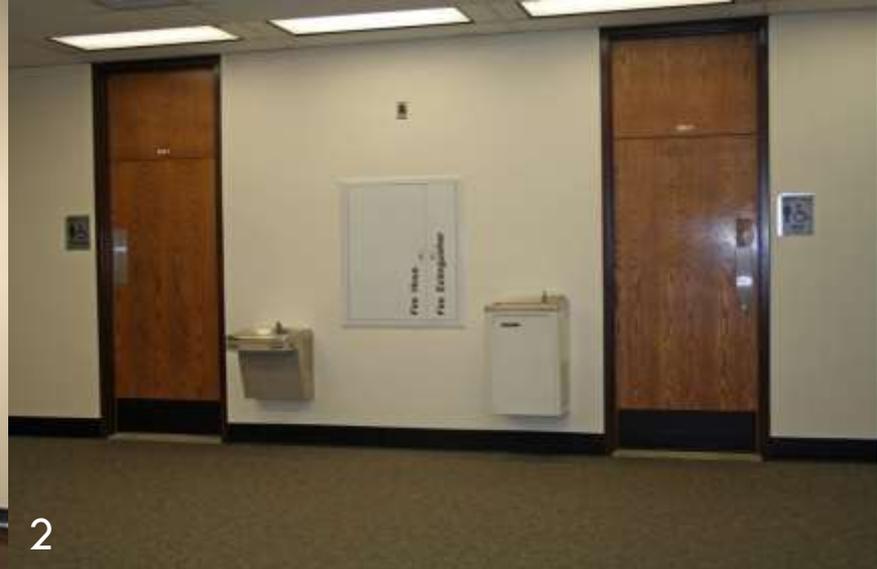
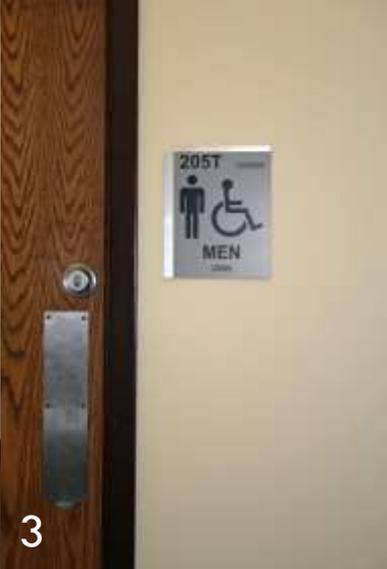
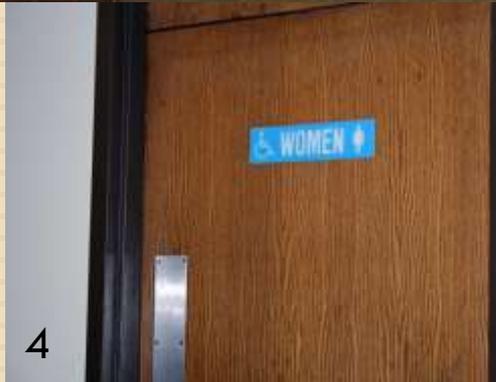
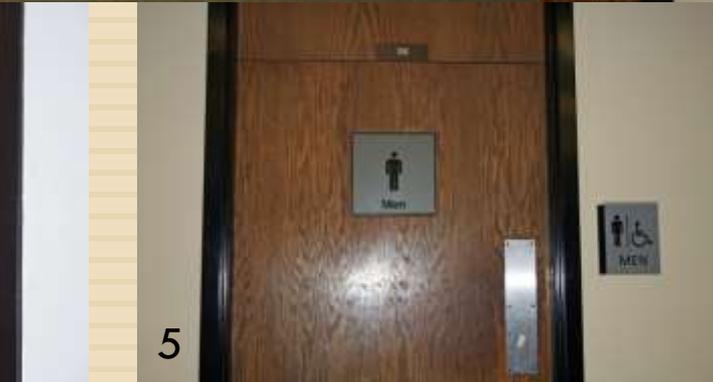
1. First floor women's restroom door with signage on door
2. Second floor women's and men's restroom door with signage on wall
3. Second floor men's restroom signage on wall
4. Third floor women's restroom door with signage on door
5. Fifth floor men's restroom door with signage on door and wall

- Add consistently styled signage throughout facility.
- Ensure signage is located at the same height on doors and walls throughout facility.
- Eliminate highly reflective signage that produces glare making it difficult to read.

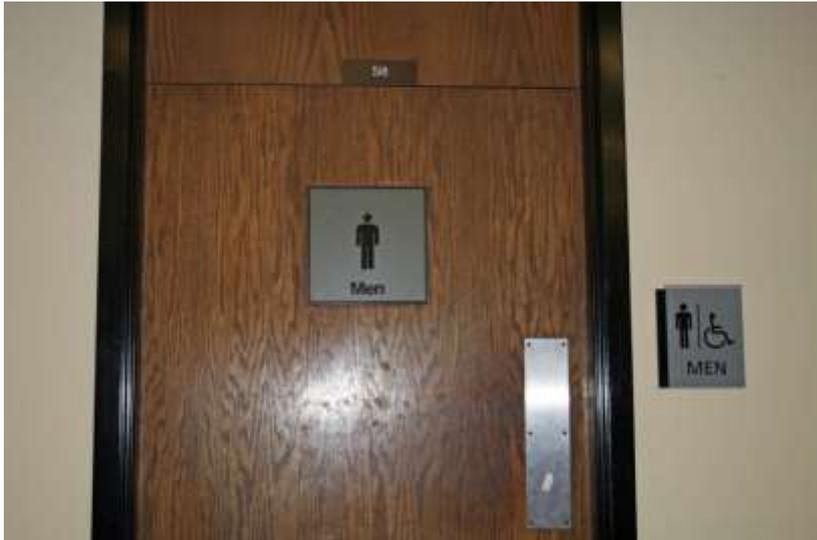
The fifth floor men's restroom is a good example of appropriate, clear signage. The signs have a matte finish and are placed both on the door and wall.

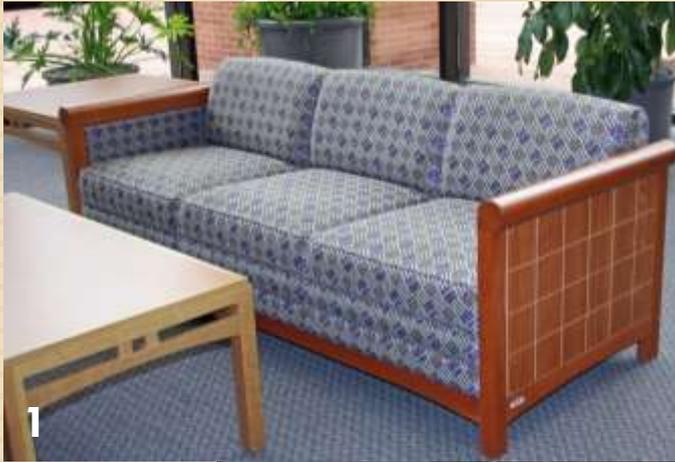
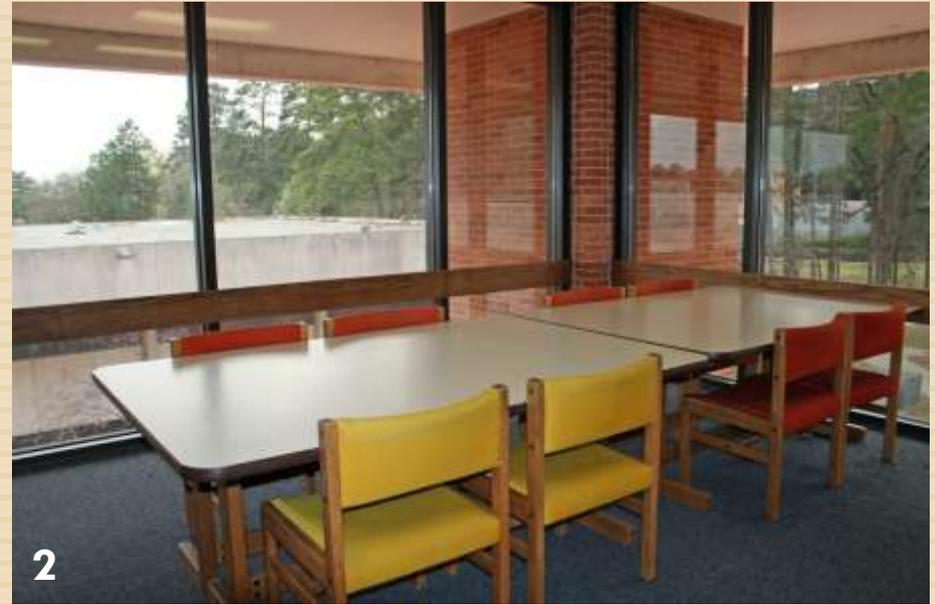
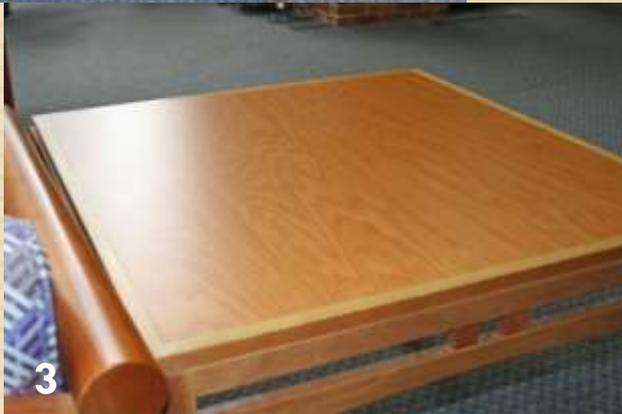
1. Couch located in front lobby on ground level
2. Desk located on the third floor
3. Side table located in front lobby on ground level

- Change upholstery on furnishings or add contrasting pillows to seating when color is too similar to flooring.
- Add blinds or shades to windows to reduce glare from sunlight reflecting off tables.

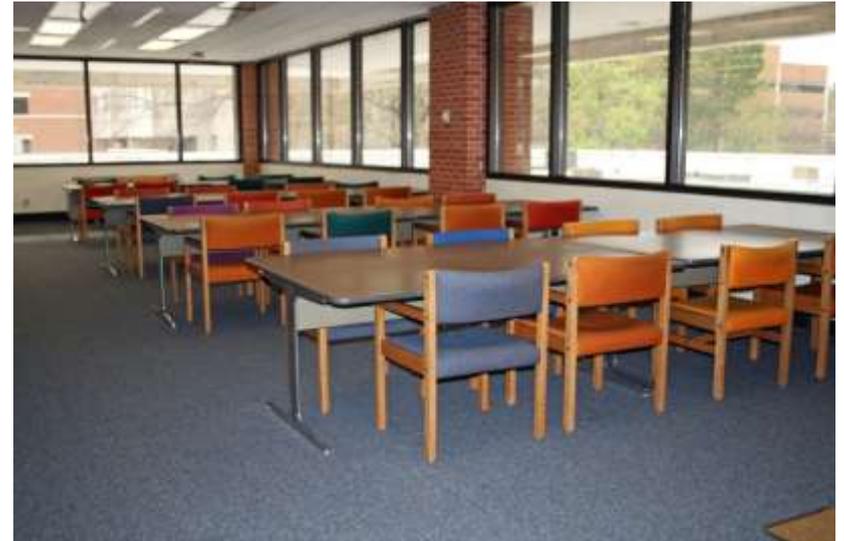
Study tables located on third floor

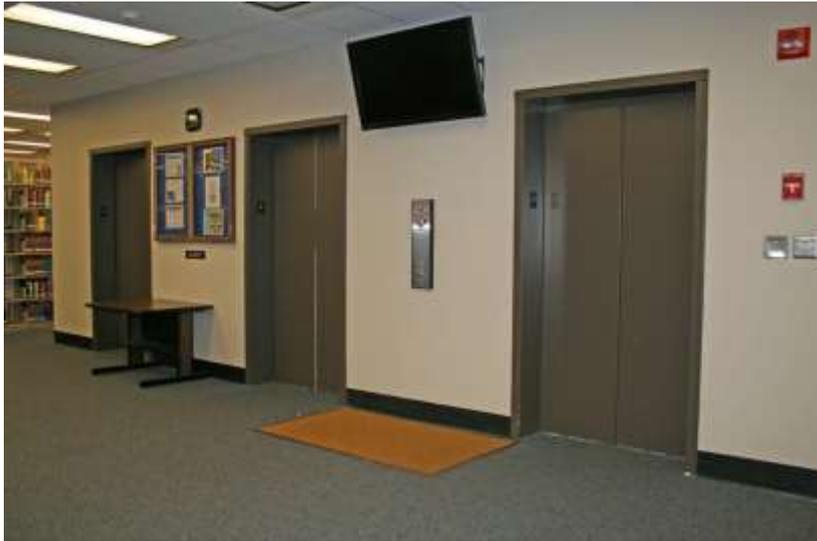
Image depicts fourth floor elevators. Mat was placed between the two elevator doors. Placing mats in front of the doors would help indicate the location of the elevator opening.

- Secure overhead signage near location of elevators.
- Place mats in front of doors as to denote where entry to elevator is located.
- Paint or place yellow non-skid tape to denote transition at elevator door.
- Paint elevator buttons red for easier detection.
